**CURTISS -  
WRIGHT**  
IMR TEST LABS

# CASE STUDY GUIDE FOR FAILURE ANALYSIS

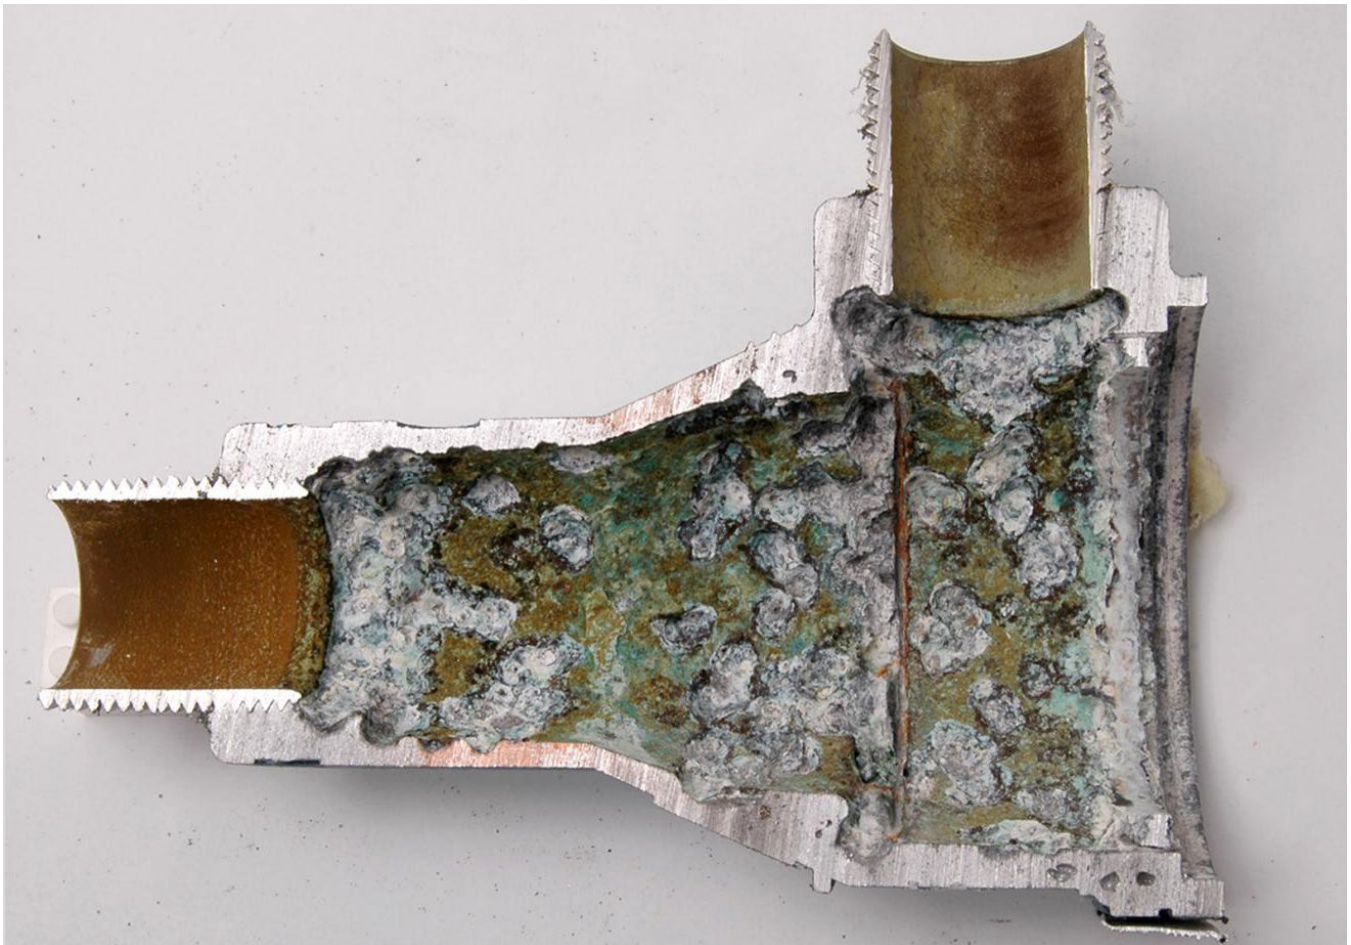
Failure analysis of a valve due to MIC (microbial influenced corrosion)

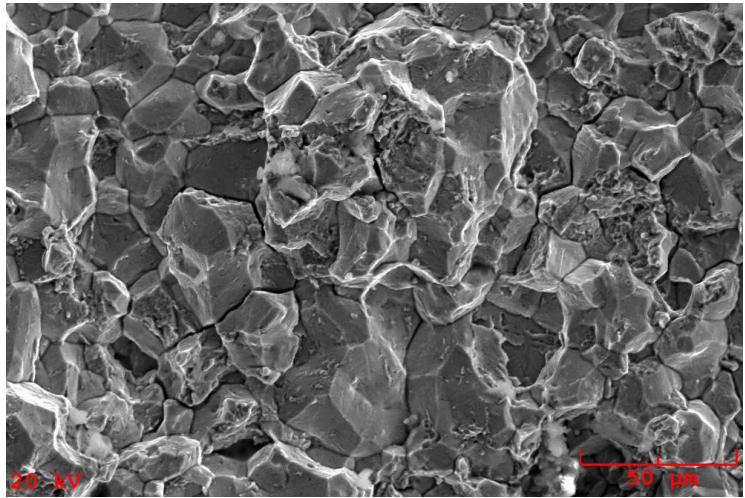
These swabs, as well as additional particulate samples taken from inside the parts, were analyzed via SEM-EDS to determine composition. The analysis showed embedded particles, primarily composed of alumina, silicon oxide, and carbides. Chlorine was also detected.

Pitting was observed on the surfaces near where the particles were collected and the fracture occurred. The part is exposed to high-temperature steam in-service in a stagnant area without a lot of flow. Condensation preferentially collects on particles, which can contribute to pitting corrosion. There is also hydrogen in the process steam, which in addition to the pitting, allowed IMR to conclude hydrogen embrittlement as a root cause for failure.

Failure analysis - hydrogen embrittlement

Recommendations to prevent future failure included evaluating the cleaning process as well as inspections of the population of parts for signs of pitting. The client also suggested switching to a component with a thicker wall to lower the local stresses to ensure structural integrity even if embrittlement were to occur in the future.

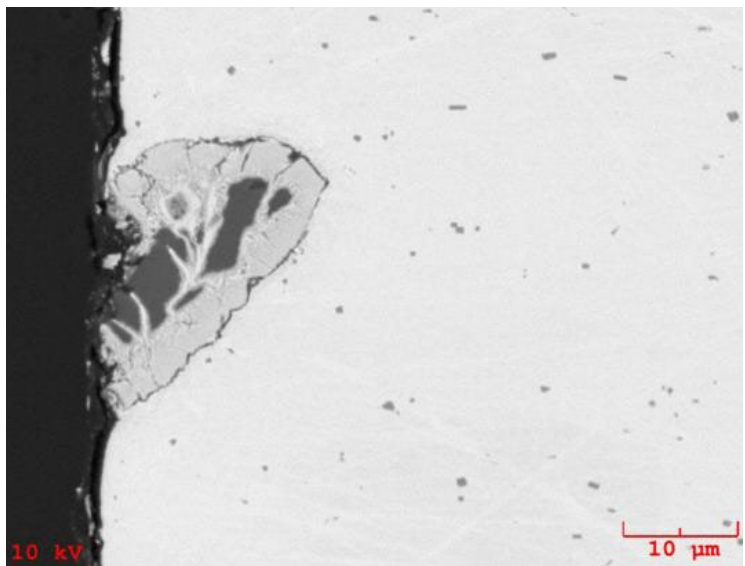
As-polished embedded particle on inner surface  
in area exhibiting pitting

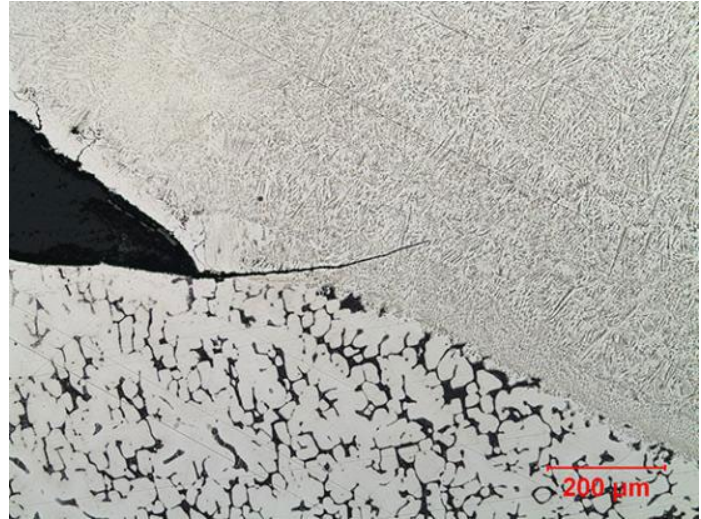
After mounting, polishing and metallographic analysis of four sections from each assembly, it was determined that all 8 locations failed to meet the customer-supplied fillet angle requirements and six of eight failed to meet weld size requirements. Samples that were taken from areas where there were no visual crack indications also contained cracks originating at the weld root.

One crack from each assembly was opened to examine the fracture surface using an optical stereoscope and a scanning electron microscope (SEM). The overall morphology of the crack surfaces is consistent with multiple origin fatigue originating at the root of the weld.

It was determined that undersized welds are the likely cause of the cracking and that there was no evidence of corrosion, weld defects or loose bolted connections.

Mounted and etched sample showing cracking originating at the weld root. Similar cracks progressed to the outside surface and were detected by the customer.

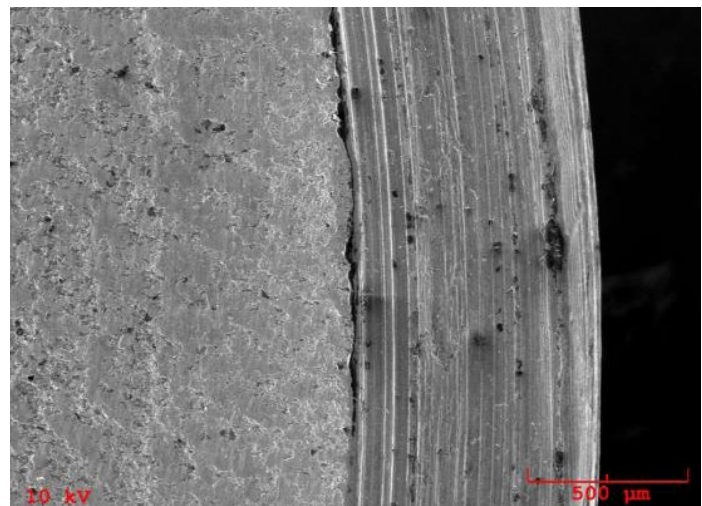
A 4150 steel pin was received for failure analysis; the fracture was determined to be due to rotating bending fatigue.

The sample was consistent with the supplied chemistry specification with the exception of a high sulfur value. This implies that the material was resulfurized for machinability.

The fracture occurred at a machined radius near the center of the pin. The machined radius exhibited rough machining lines which may have acted as crack initiation sites. A finer finish on the part would likely result in improved fatigue performance.

SEM view of the fracture surface with deep machining mark at the edge.

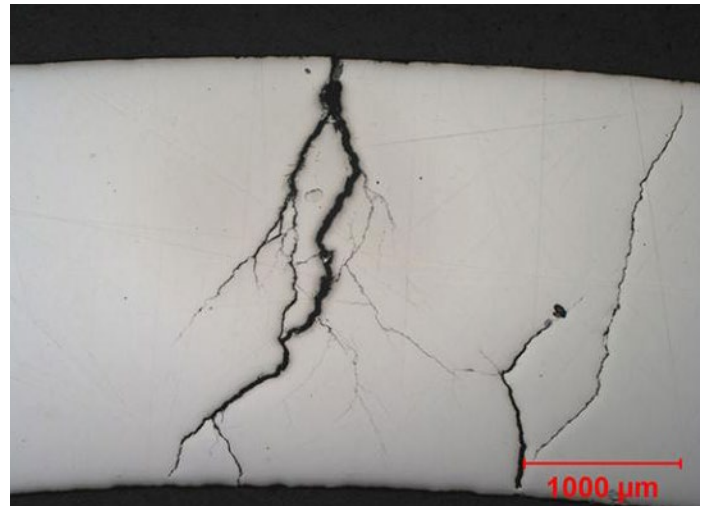
One pipe showed minor pitting and the other contained a network of fine cracks. The cracks appear to have originated on the outside of the pipe. Both pipes were covered with debris.

Failure analysis of cracks in the pipe section – as polished

The DI water contained numerous sodium chloride deposits. Ion chromatography (IC) testing confirmed that the DI water sample contained 9 ppm of chlorides. This is the likely source of chlorides that caused the corrosion.

The debris on the surfaces of the tubes was from the silica-based insulation and contained sodium and chlorine, likely from trapping moisture against the pipes. 300 series stainless steels are susceptible to stress corrosion cracking (SCC) in moist chloride environments

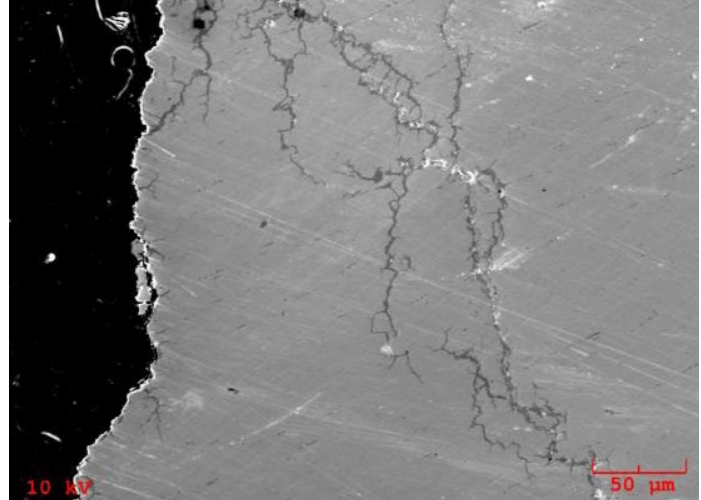
The chemistry and hardness of the locking pin are consistent with the tool steel as specified on the drawing. The locking pin fracture surfaces exhibited some coarse transgranular texture in undamaged areas. Only a very small area of ductile dimples were observed. The fracture surfaces appeared quite complex indicating a possible corrosion mechanism was present. Fractography and microstructure examination confirmed that the pin experienced transgranular SCC.

Secondary electron image of pin cross section near the fracture surface. Note complex crack pattern indicative of caustic stress corrosion cracking.
