Arresting Stress Corrosion Cracks in Steam Turbine Rotors

Russell Chetwynd
Southern California Edison

ARRESTING STRESS CORROSION CRACKS IN STEAM TURBINE ROTORS

**EDISON INTERNATIONAL
SOUTHERN CALIFORNIA EDISON**

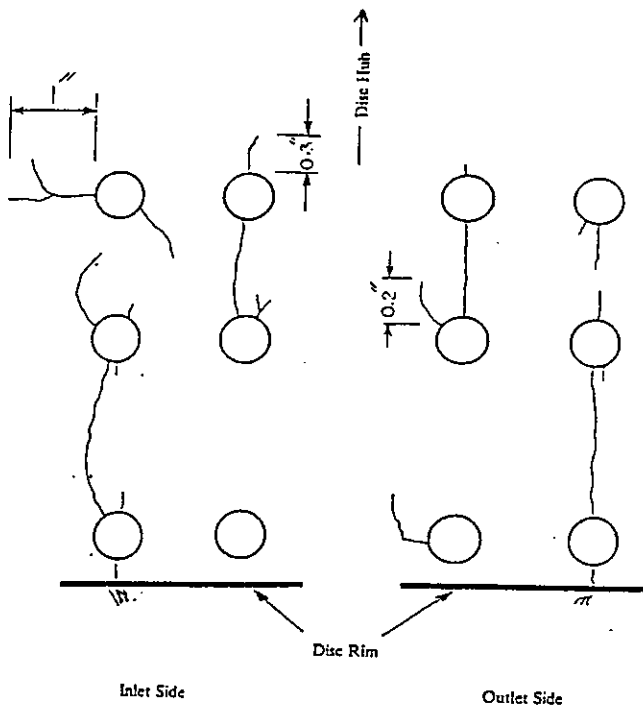
The cracking in this area was surprising to SCE as it had not been reported by others operating similar turbine designs. The cracking; however, was consistent with cracking reported on nuclear machines with pin root attachments and similar rotor construction technology. It was not discovered until the LP3 turbine front stage 4 disc, closing blades were removed for investigation of the dovetail cracking detected by UT NDE. This disc had the most extensive, through wall, cracking (Figure 1) which was radial and transverse to the ligaments between the three pin holes and also through to the disc rim. The most alarming crack; however, extended from one of the bottom pin

Figure 1 Unit 2 Lockup Blade Region Cracks, LP3 4F

The general repair methodology for the less extensive closing blade pin hole cracking was enlargement by machining followed by shot peening. The pin hole enlargement resulted in unloading the holes. The LP3 turbine stage 4 front disc pin hole cracking was left as is with the exception of the crack extending from the bottom pin hole towards the disc rim. This crack was excavated consistent with the diameter of the pin hole and shot peened. The remainder of the pin holes were enlarged and shot peened. The cracks through the ligament between the pin holes were left without change, since they were deemed as harmless, and could not propagate.

The stage 4 blades were reassembled with a clearance between the pin holes and the pin to eliminate high local contact stress. Crosskeys installed between the adjacent blade platforms, above the wheel rim, were used to assist in support of the closing blade. Note: As discussed later, similar crosskeys were installed between blade platforms at areas of the disc rim with extensive dovetail excavations.

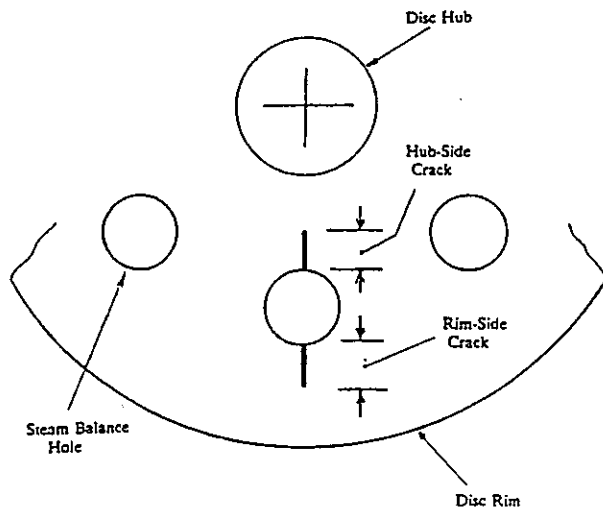
Steam balance hole cracking was discovered on both stages 4 and 5, with stage 4 being the most severe. The cracking was difficult to detect by MT NDE technique without first reaming and polishing the holes in order to achieve a smooth surface finish and UT inspection techniques was also used in parallel to help quantify the extent of each defect discovered. The cracks were found to originate at the surface and were oriented radially at the 6 and 12 o'clock positions with respect to the disc center line. They were found to initiate both at the corner locations and in some instance at the mid section of the disc. In all cases they propagated towards the disc bore and the disc rim. (Figure 2)

Figure 2 Typical Steam Balance Hole Cracks

The cracking was repaired by a combination of grinding and machining with the machinists and inspectors working in a team in a similar manner to the dovetail repairs. Typically, cracks were first removed by local milling until cleared by MT inspection, with maximum excavation depths provided by Engineering as an upper bound value. The holes were then machined to a larger diameter, with an offset center if necessary, to remove the ground out areas. In some holes, where the cracking had not extended through the thickness of the disc, the

cracks were partially removed by boring a larger hole and the remainder (< 0.1" deep) removed by grinding and blending. Following the boring operations a generous radius was machined on the edge of the holes. Finally, the holes were shot peened with a manual procedure developed jointly by the OEM, the shot peening contractor and SCE.

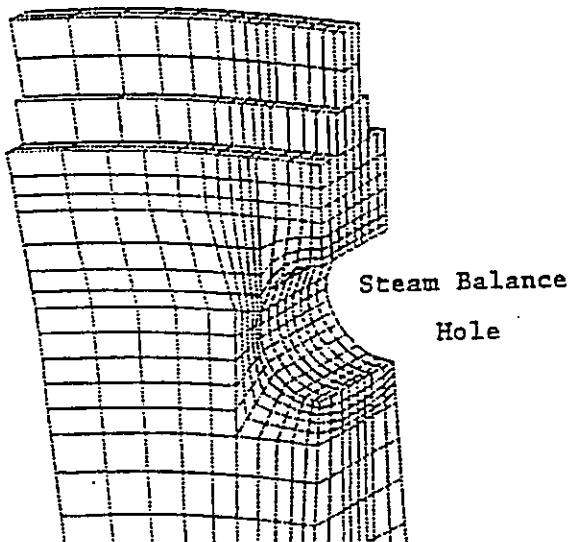
Figure 3 Stage 5 Finite Element Model

Figure 3 shows a closeup of the finite element model, representing a segment of the disc containing one steam balance hole, used to evaluate stage 5 disc repairs. The figure shows the steam balance holes, the disc head and part of the disc hub.

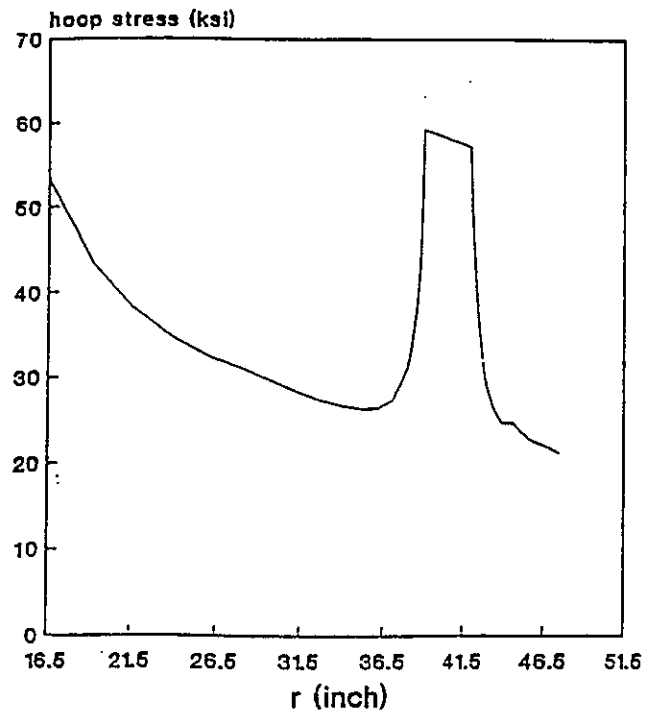
Figure 4 Hoop Stress Distribution

Steady state structural analysis was performed to calculate the distribution of the stress components in the steam balance hole region. Analysis results show that the dominant stress component acts in the tangential (hoop) direction of the disc, as expected. Figure 4 shows the distribution of the hoop stress in the disc as a function of the radial distance. The stress concentration effect of the steam balance hole can be clearly seen. The stress increase factor, due to the steam balance hole, is about 2.5. This explains why all steam balance hole cracks were in the radial direction.

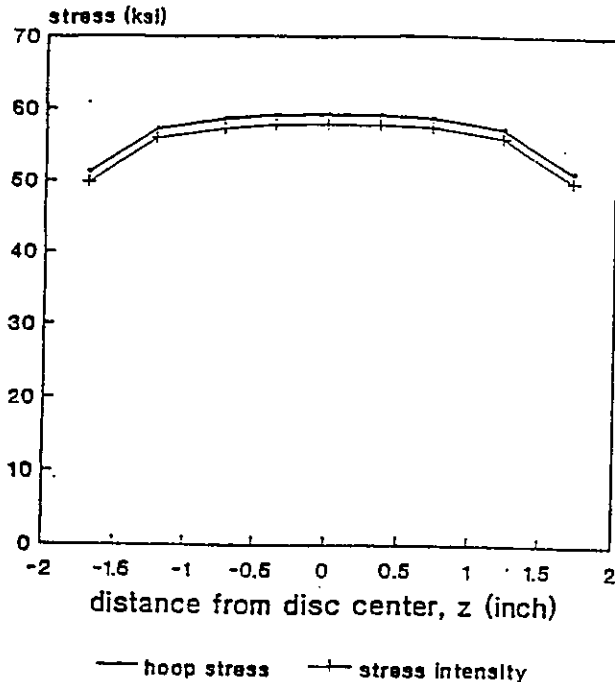
Figure 5 shows the hoop stress distribution across the thickness of the disc along the edge of the steam balance hole. The variation is less than 10%, with the stresses slightly higher in the middle of the disc.

Figure 5 Hoop Stress Versus Disc Thickness

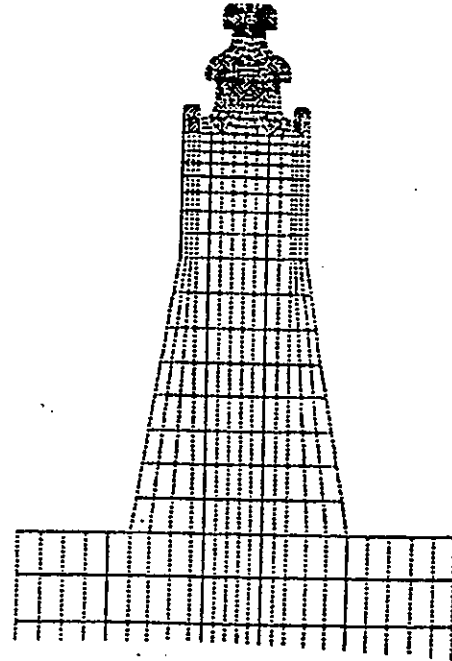
A finite element-based structural analysis of all the discs impacted by the excavation repairs. Figure 6 shows a typical axisymmetric model generated stage 5 of the LP turbine. Centrifugal loads, blade loads and loads due to the disc-shaft shrink fit were applied. Excavations were conservatively modeled as cracks emanating from the hook fillets into the disc head material. Different crack

Figure 6 Stage 5 Disc Head

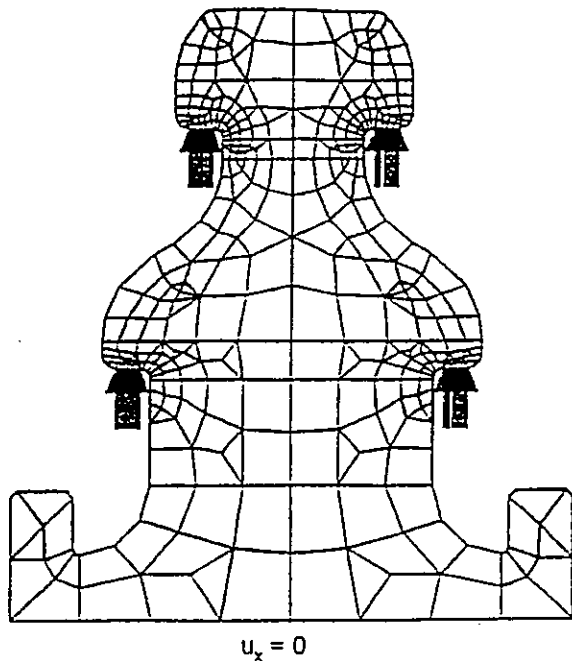
Fracture mechanics evaluations were performed to assess the potential for brittle fracture. Cracks were postulated at the locations of the disc head excavations. Finite element models of the impacted disc heads were generated, as shown in Figure 7. The figure shows the applied loads and the boundary conditions. The finite element-based fracture mechanics program FRANCXT was used to calculate the stress intensity factor, K_I , as function of the crack depth. Figure 8 shows a sample of the results obtained for stage 5 disc heads.

Figure 7 Disc Head Model Used in the Analysis

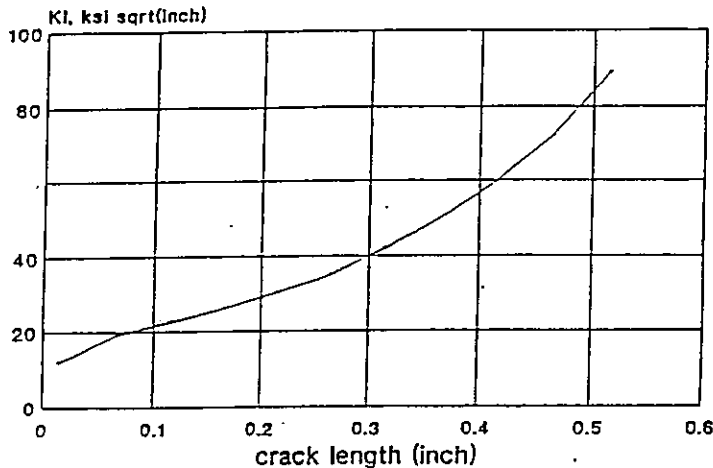
Results show that ductile failure is limiting, i.e., the disc head shoulder will fail plastically before K_I reached the critical stress intensity factor K_{IC} .

Figure 8 K_I versus a
