**CURTISS -
WRIGHT**
IMR TEST LABS

CASE STUDY GUIDE FOR FAILURE ANALYSIS

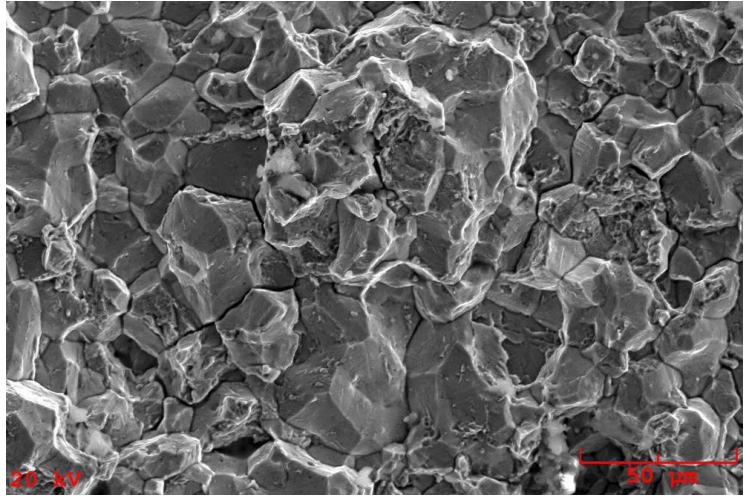
Failure analysis - hydrogen embrittlement

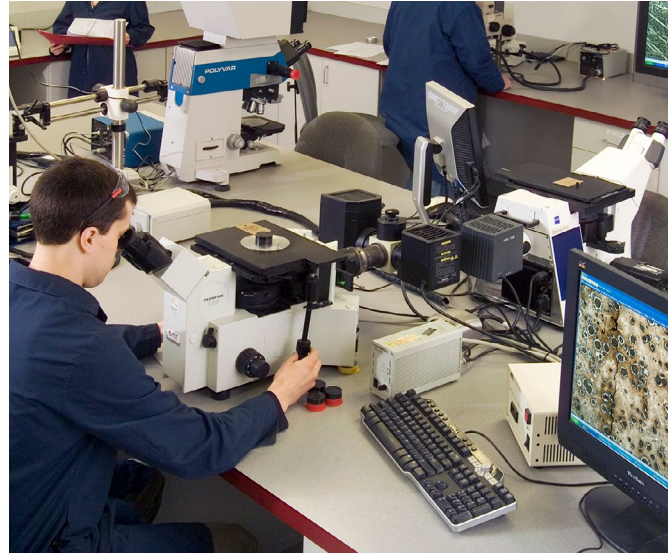
With a full chemistry lab (including non-metallics) and a well equipped mechanical fatigue lab, our engineering staff has numerous resources to help you and your team.
