Preventing Stress Corrosion Cracking and Enhancing Corrosion-Fatigue Performance of Steel and Aluminum by Laser Peening; deployment on nuclear spent fuel canisters.

A Lloyd Hackel¹, B. Jon Rankin¹, C Matt Walter¹, D Brent Dane¹

¹ Curtiss-Wright Surface Technologies, 222 Mountain Vista Parkway, Livermore, California, 94551, USA

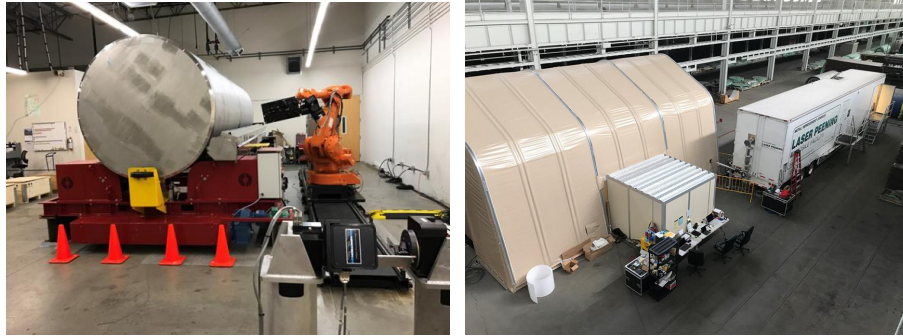
Figure 15. Laser peening system configured for treating welds of nuclear spent fuel canisters. At left beam director mounted on the robot (orange) for canister processing. At right system configured for field operation.

Taking the technology beyond the qualifying laboratory tests and evaluations to field deployment was an important step for fully demonstrating the capability of the laser peening process to support nuclear applications. A highly automated laser and robotic system was configured to peen the welds of 75 MPCs for the San Onofre Nuclear Power Plant at the Holtec International canister fabrication facility. The right hand photo of Figure 9 shows the beam delivery hardware and robotics that precisely positioned the laser beam spots onto the canister. A rotation system rotated the canisters to peen the hoop welds and with rotation fixed, the delivery robot translated along a track for peening the longitudinal welds. Individual spots were placed on the canister with 0.1 mm precision and recordings made of laser energy and pulse duration for each shot. The canisters were peened with a 100 mm (4 inch) wide coverage at 4 GW/cm² irradiance, 18 ns pulse duration and 3 layers of coverage. The photo at right shows the laser peening system as deployed at the manufacturing facility. The UL qualified laser system is housed in a trailer and its output beam is propagated into a light safe tent and to the beam controller mounted on the delivery robot. The beam controller precisely conditions the spot and directs it on to the canister. The water delivery nozzle is attached to and move with the controller. Processing is controlled by operators at the external control station. Canisters were peened at the rate fabricated and the laser system returned to California home base when peening was completed.
