# The Continuing Dangers of Tin Whiskers and Attempts to Control Them with Conformal Coating

Jong S. Kadesch  
Orbital Sciences Corporation/NASA  
Jong.S.Kadesch.1@gsc.nasa.gov  
301-286-2785

Jay Brusse  
QSS Group, Inc./NASA  
Jay.A.Brusse.1@gsc.nasa.gov  
301-286-2019

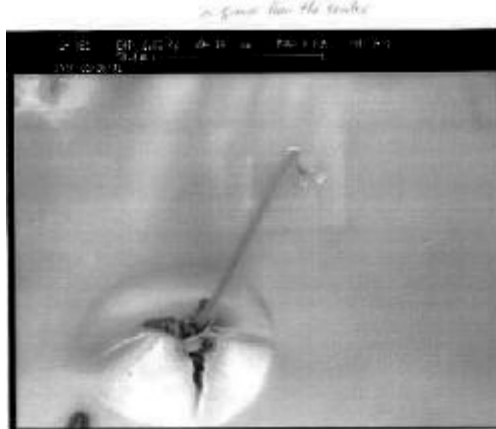
Figure 1. SEM photo of a tin whisker breaking out from beneath conformal coating (x625)

Figure 1 shows the most extreme observation we have recorded to date where a tin whisker has actually grown through the conformal coating approximately 2 years after application of the conformal coat. Attempts to measure the actual thickness of the coating at this location have been difficult because this area of the test specimen has a relatively thin layer of conformal coat. Estimates of the coating thickness in this location are on the order of 1/4 mil. After emerging from the coating, the tin whisker can become a risk for inducing short circuits. As noted previously, there are numerous other whisker growths beneath the thicker areas of conformal coating (~ 2 mil thick) that we anticipate will eventually penetrate the conformal coating. With some NASA missions extending over 10 years, and a few to 20 years, it is possible (but not confirmed experimentally) that coatings even as thick as 10 mils may not prevent whiskers from protruding.

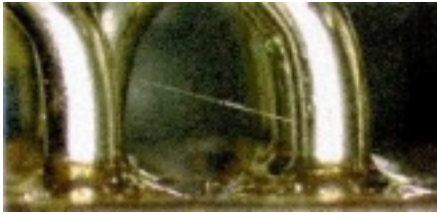
Electromagnetic relay terminals  
*Photo courtesy of NASA GSFC*

Ceramic chip capacitor termination  
*Photo courtesy of Ericsson*

Hybrid microcircuit lid  
*Photo courtesy of JPL*

Figure 2. Examples of Tin Whiskers Growing on Pure Tin Plated Electronic Components

The growth of tin whiskers on pure tin plated electronic components and associated hardware has been documented for decades. Notable examples of pure tin plated components that have exhibited tin whisker formations include electromagnetic relays, transistors, hybrid microcircuit packages, terminal lugs and very recently ceramic chip capacitors. A few such examples are shown below in figure 2:

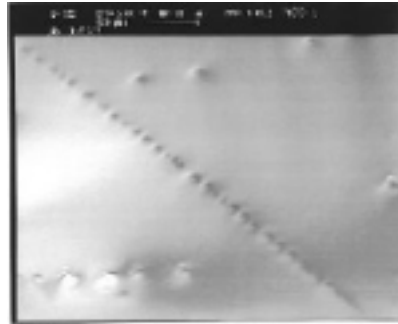
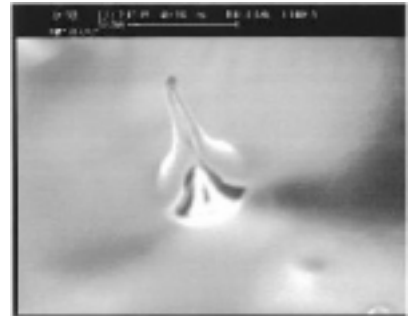
Figure 3 shows the formation of tin nodules beneath the conformal coat on several specimens. Such growths under the conformal coating are common on all of the specimens regardless of storage conditions (room temperature vs. 50°C). In these SEM images the tin whiskers resemble a spike being pushed into a rubber membrane, deforming the surface into a sharp-tipped cone. It is interesting to observe that many of the whiskers in Figure 3 formed along a surface scratch or defect in the substrate that was NOT intentionally introduced. These minor defects were most likely present on the substrate prior to plating or were introduced through the handling of the specimens just prior to initiation of the experiments. This observation raises the concern that basic handling during manufacturing or user assembly may impart stresses to the plating surface which become nucleation sites for whisker growths.

Figure 3. SEM photos of tin domes forming beneath conformal coating

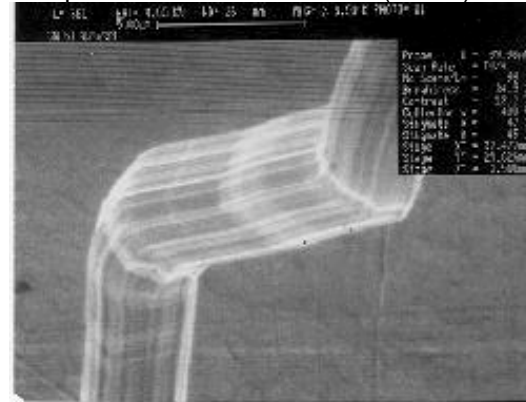
D. Kinked area of a whisker (x6500)
