# Qualification and Implementation of Laser Shock Peening on F-35 & Lessons Learned

Presented by – Scott Carlson  
Scott.Carlson@lmco.com  
*Lockheed Martin Aeronautics  
F-35 Service Life Analysis Group  
Fatigue and Crack Growth Methods Lead  
Co-Authors Listed Later in Presentation*

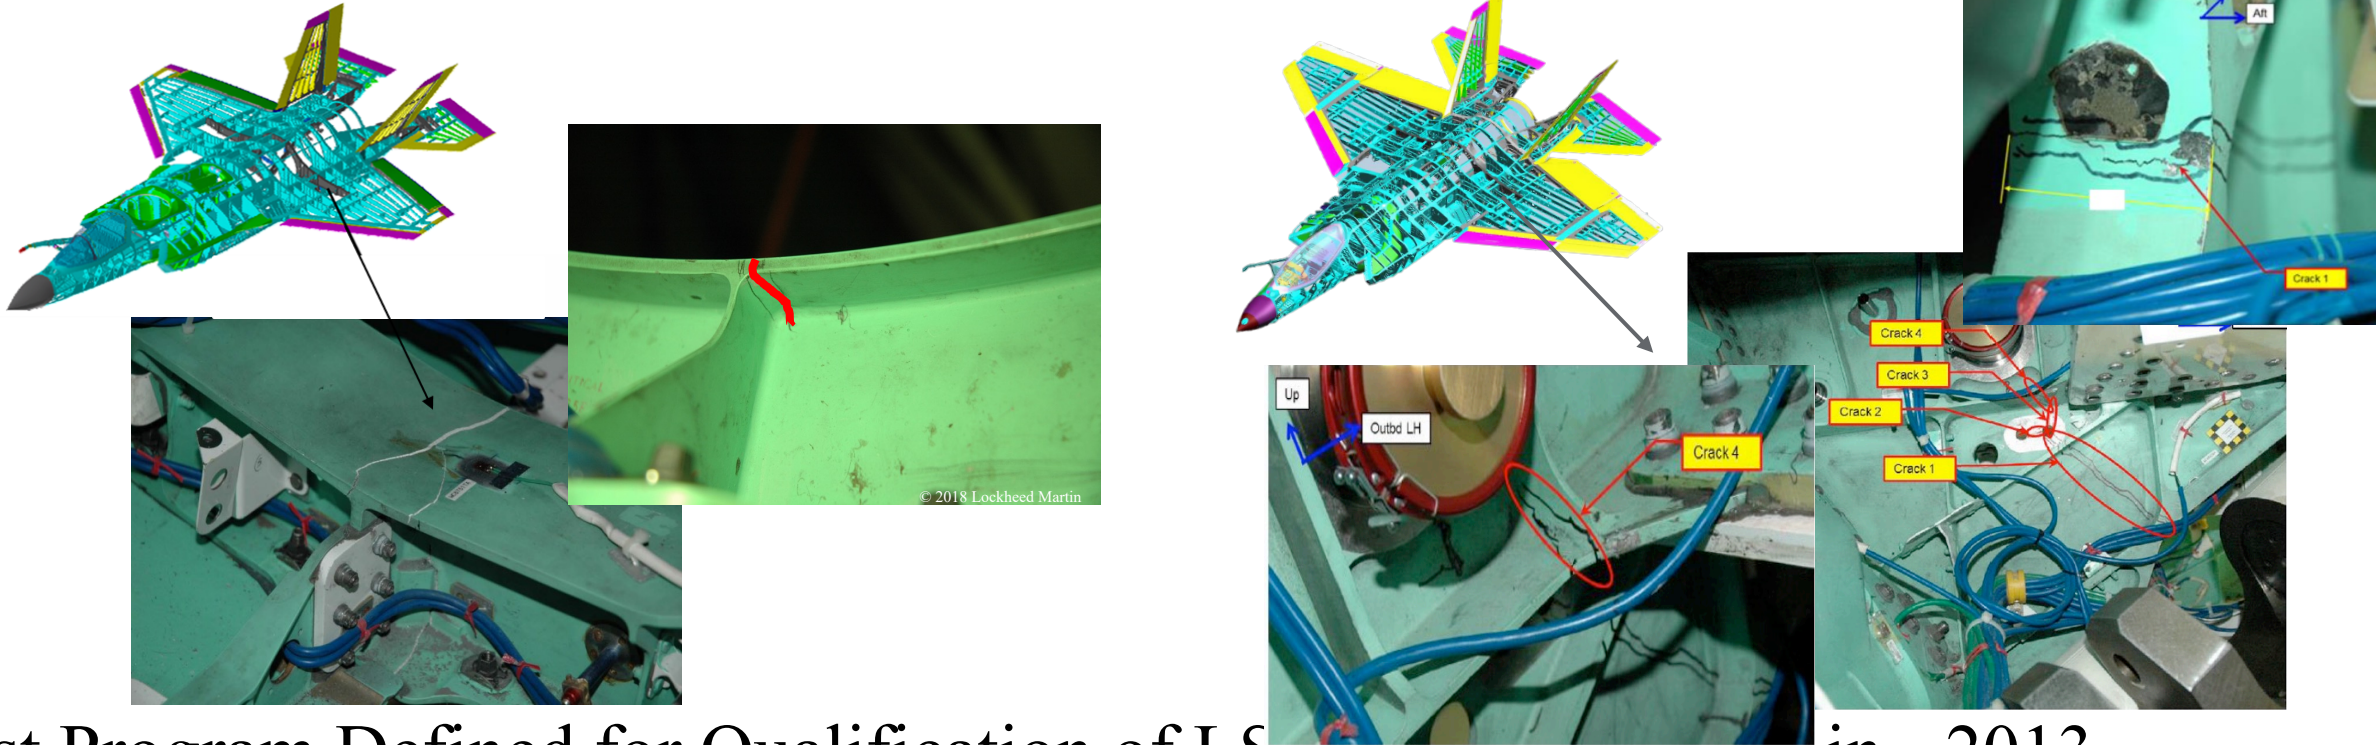
- F-35B & C Full-Scale Durability Test (FSDT) Started - May 2010<sup>1</sup>

- Test Program Defined for Qualification of LSP for Life Benefit in - 2013
  - Development and application of Metal Improvement Company's (MIC) LSP process and methodology to enable life requirements<sup>2</sup>
  - F-35B has completed all certification requirements and F-35C has one more area to qualify

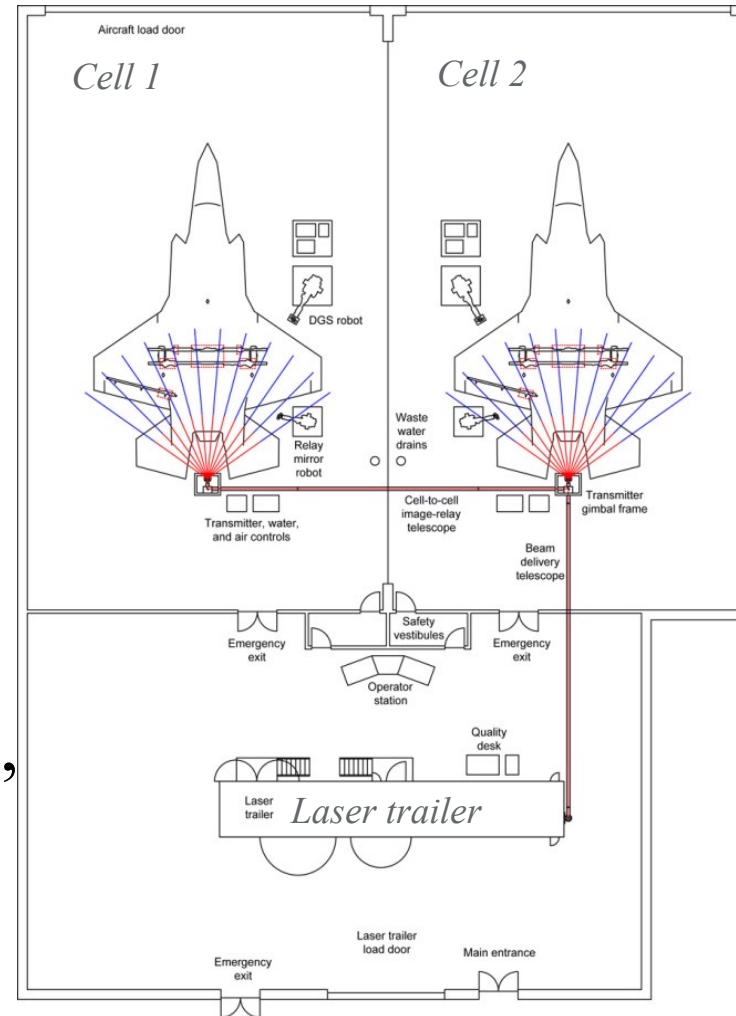
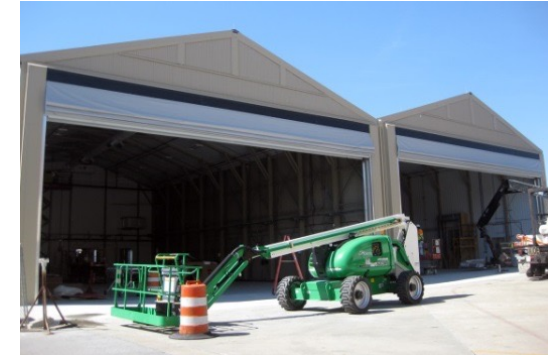
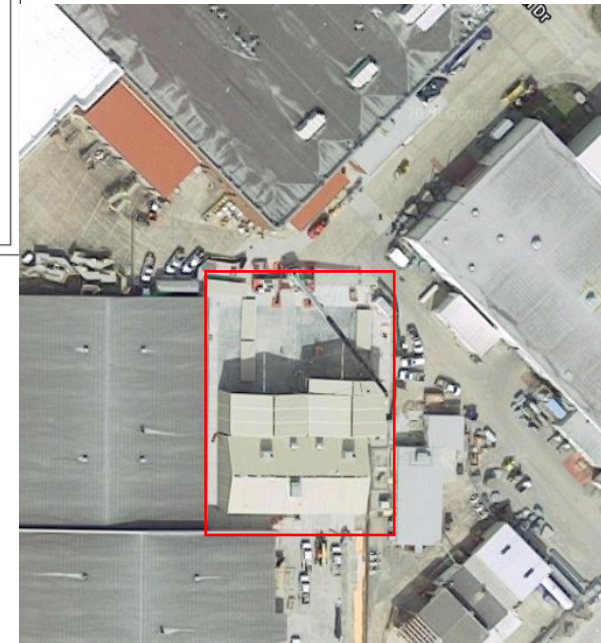
FRC-E F-35 Installation

- 2-Cell System Enables Concurrent Processing of 2 Aircraft
- Concurrent Work in Both Cells
  - Cleaning, inspection, taping, and robot positioning occurs in a cell
  - LSP applied in other cell
  - Interlocks ensure safety and efficiency of process
- Full Scale Test Article (BG-1) Utilized for LSP Process Deployment, Testing and Validation
  - At CWST laser facility (Livermore, Ca)
  - At FRC-East (Havelock, NC)

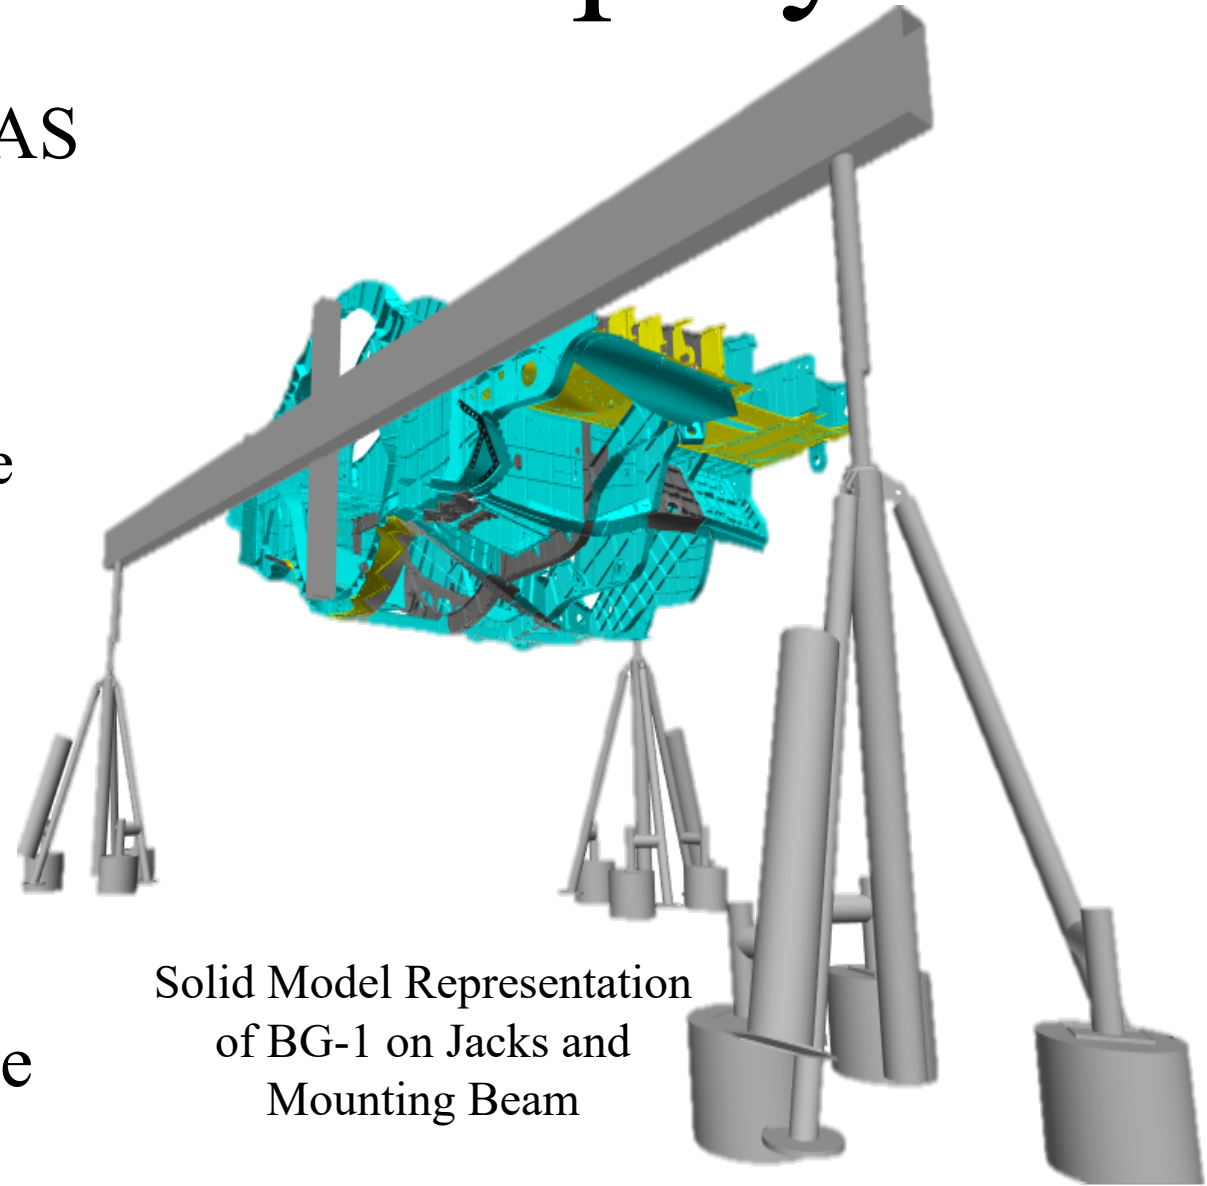
- Sectioning of BG-1 Performed by the Weapons Survivability Lab, China Lake NAS
- Delivered to MIC-Livermore in Late 2018
- Asset Mounted on a Surrogate Frame
  - Approximately represent jacking positions of the real airframe
- BG-1 was Invaluable for Development, Testing, and Demonstrating the System
- BG-1 is Key for Continuous Improvement
  - Development of LSP locations continues
- CG-1 Performing the Same Function for the F-35C Development

Solid Model Representation  
of BG-1 on Jacks and  
Mounting Beam

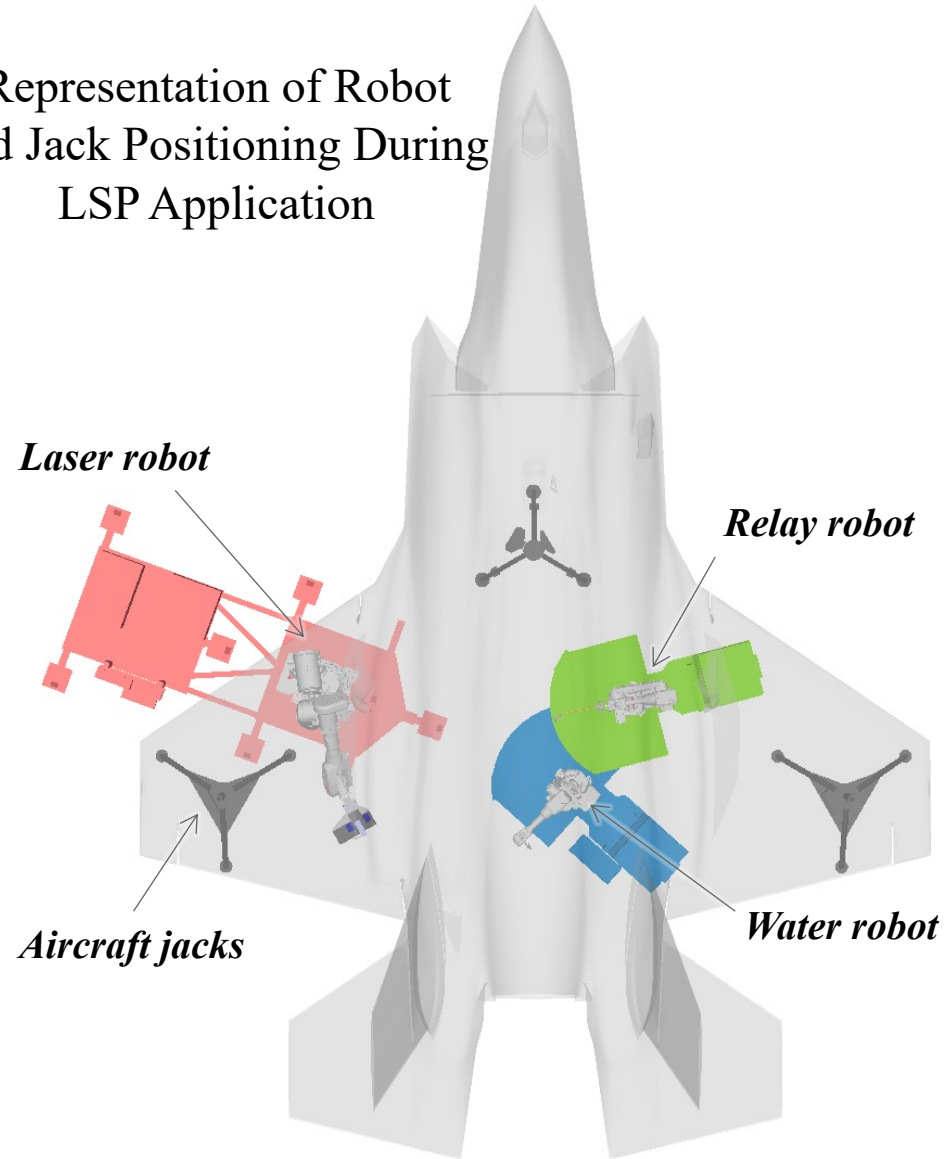
Representation of Robot and Jack Positioning During LSP Application

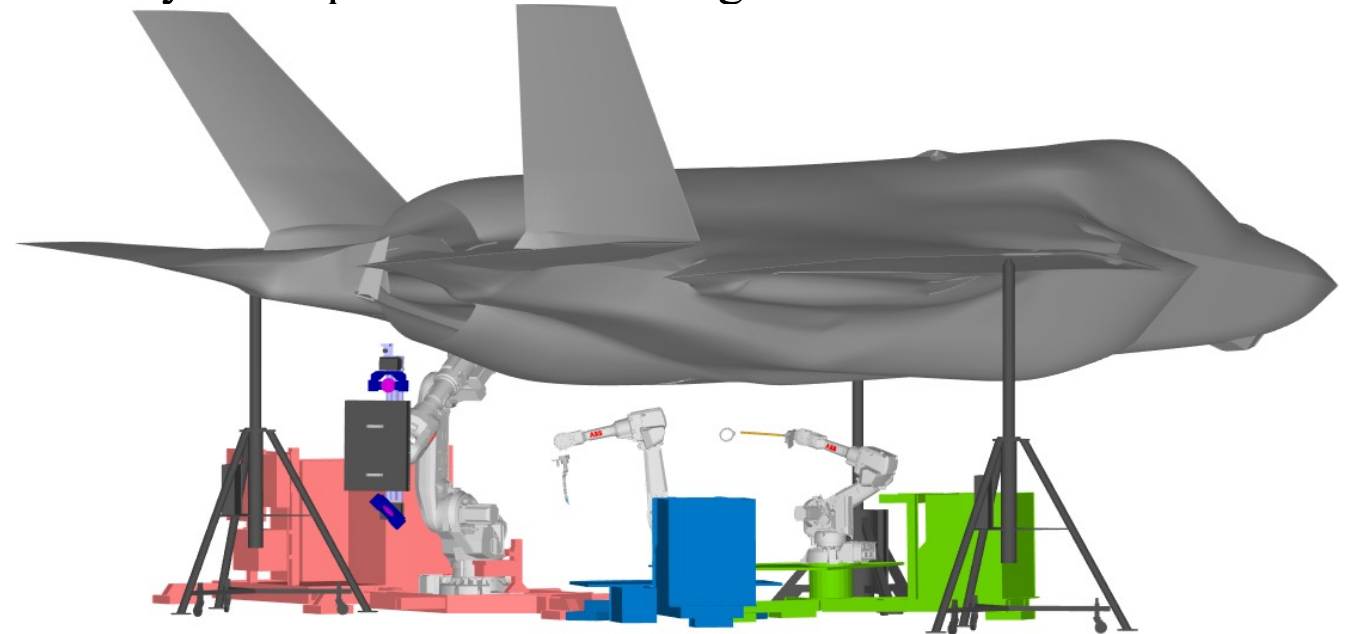
- Three Floating Robots can be Reconfigured as Needed Under and Around the Plane to Apply LSP
  - Laser delivery robot brings the beam from the transmitter to the plane
  - Water robot applies tamping water layer on a shot-by-shot basis
  - Relay robot provides line-of-sight to hidden areas

Solid Model Representation of Process Robots for LSP Application

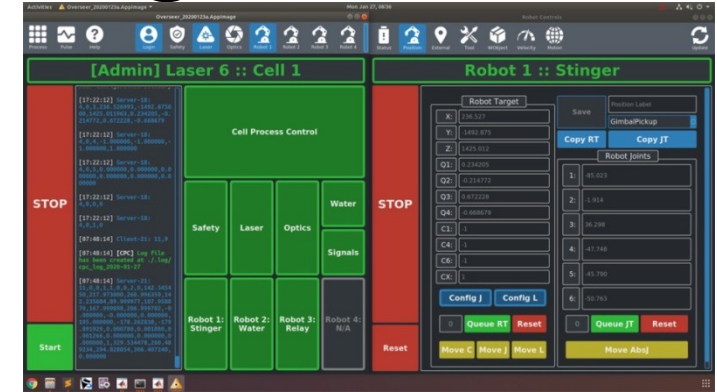
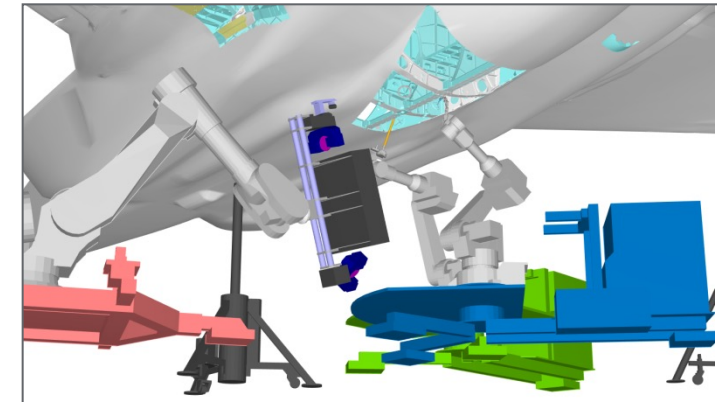
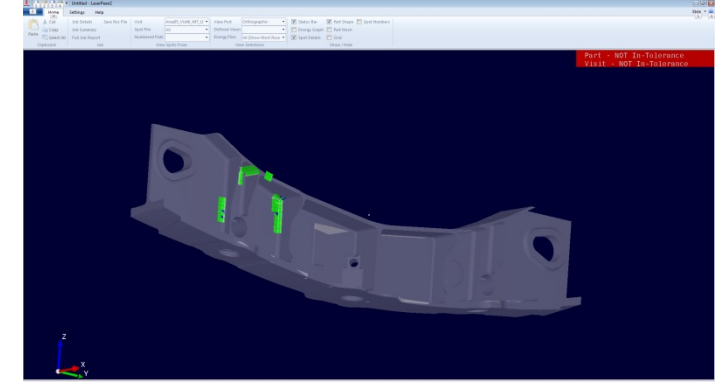
- Patterns are Designed and Maintained on OEM CAD Files Using Original Aircraft Coordinates
- Script-based Control System Allows for Quick Customization
  - F-35B has multiple geometric configurations for same locations
  - Due to design changes during Low-Rate Initial Production (LRIP)
- Monitoring Tools Allow Users to Visualize Simulation of Robot Motion Before, During and After Processing
- Key Process Parameters on a Shot-by-Shot Basis are Digitally Stored, Used for Quality Assurance<sup>8,9</sup>
  - Integration into Digital Thread with validated residual stresses

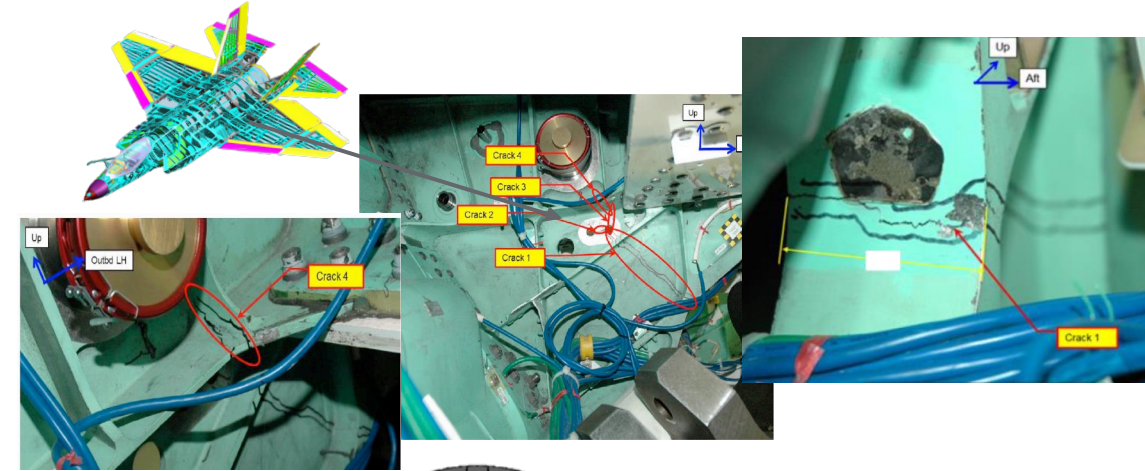
- Previous Presentations Provided Overview of Application of LSP to F-35C's Titanium Bulkhead Locations<sup>11-13</sup>
  - Three locations on bulkhead
  - Leveraged previously developed LSP settings for Ti-6Al-4V BA ELI
    - Reduced time for completion to 3 years instead of 6 for STOVL
    - Eliminated “Element” testing
    - Reduced number of bulkheads purchased due to reduced number of testing coupons required
  - Changed grip type to reduce number of lug failures
  - Applied ForceMate™ bushings to lug holes

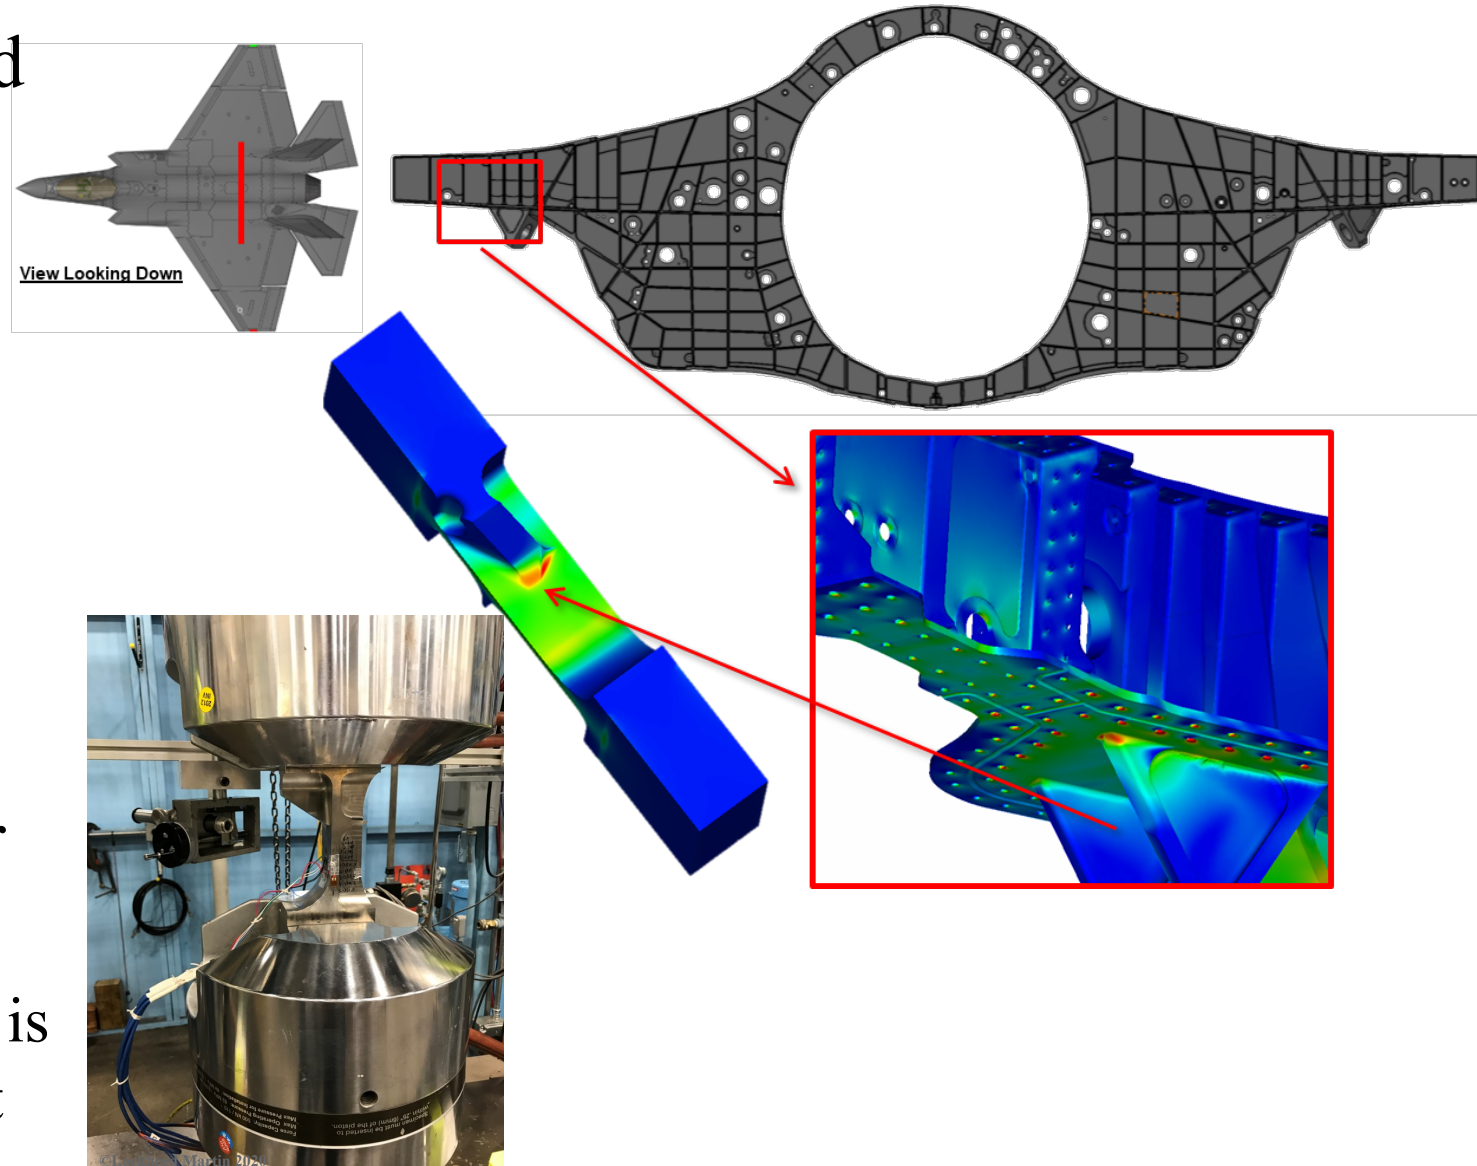
- Subcomponent Testing Completed
  - 2 Baseline, No EDM notch tests
  - 1 Baseline, EDM notched test
  - 2 LSP, No EDM notch
  - 1 LSP, EDM notched
- Tested in a 110kip MTS Load Frame
- Time to a 0.01inch Crack was Based off of Time to First Marker Band Found
  - For Ti-6Al-4V BA ELI the grain size is greater than the 0.01inch requirement

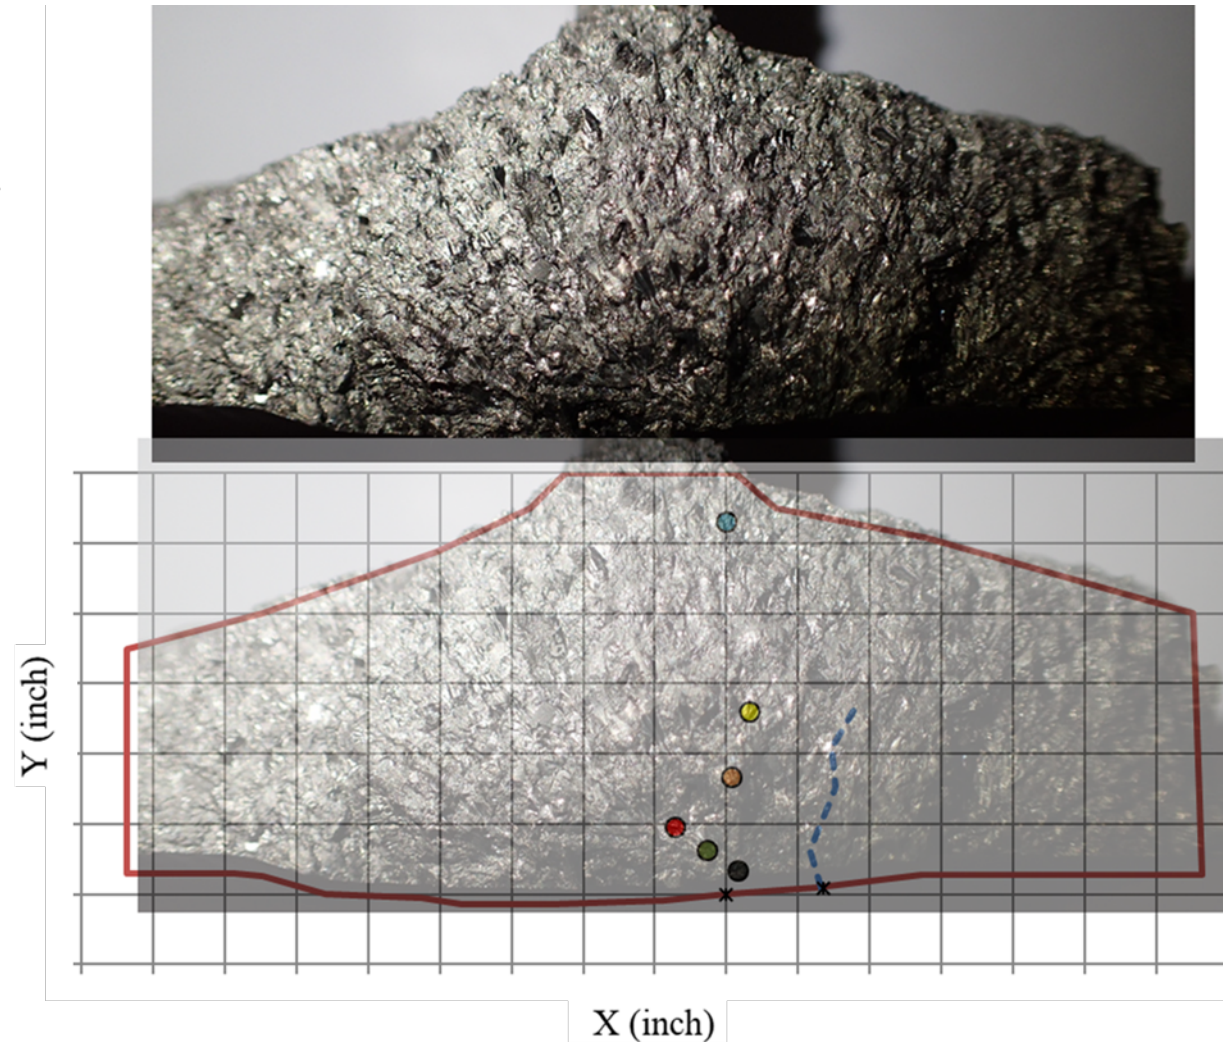
- All Baseline Subcomponents Failed in Gauge Area
  - Marker banding was able to find marker bands down to Avg. 0.055inch
  - Developing marker bands below approx. 0.03inch is very difficult in Ti-6Al-4V BA ELI<sup>14,15</sup>
- EDM Notched and Non-Notched Performed Very Repeatably
- Matched the FSDT Results for Fatigue and Crack Growth
- Great Confidence in Testing Execution

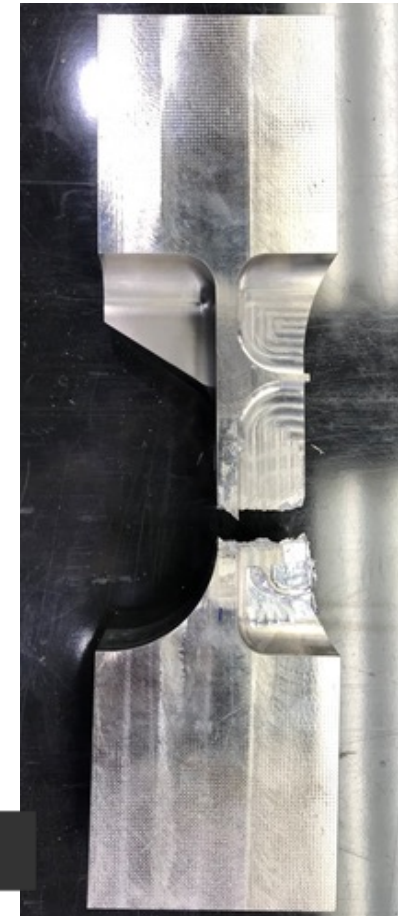
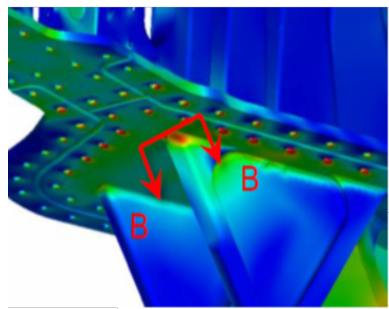
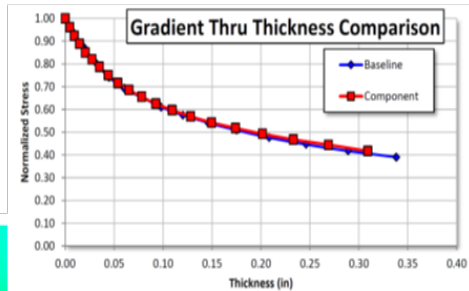
- All of the LSPed Subcomponents Failed Outside of the Test Gauge Area
- All Fatigue Tests (No EDM Notch) Went **Over 2x** the Requirement
- All Crack Growth Tests Went **3x** the Requirement
- At the End of All Tests No Cracks were Found in the Test Section
- Stress Gradient at Trunnion is **Steep & Shallow** – Perfect for LSP!

Subcomponent Cross-Section

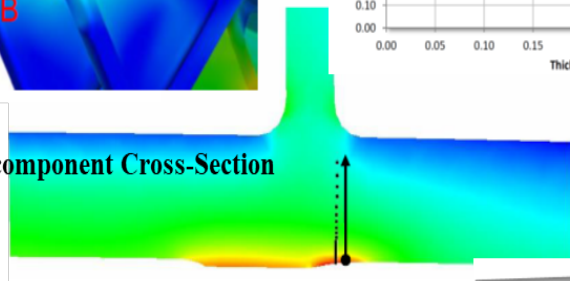
Local Stress from Applied Load

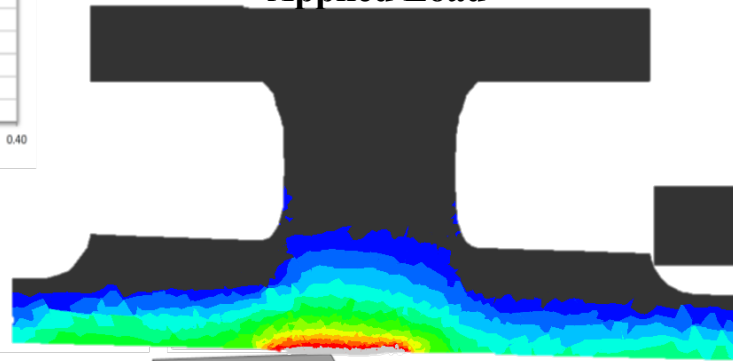
Combined Stress from Applied Load and LSP Residual Stress

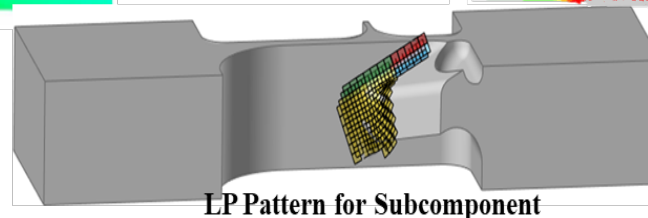
LP Pattern for Subcomponent

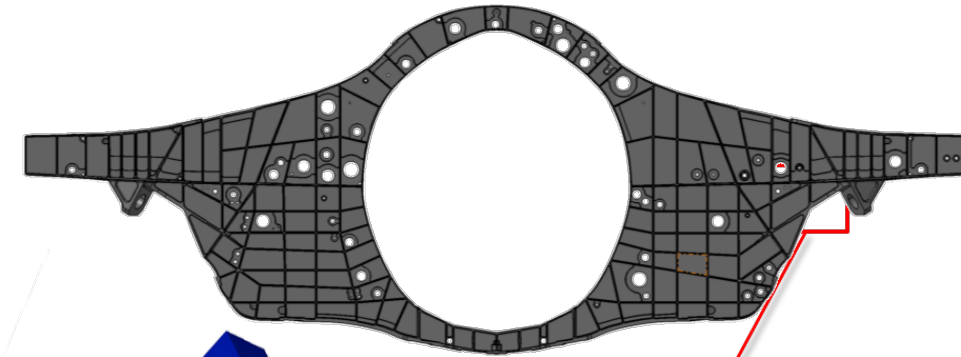
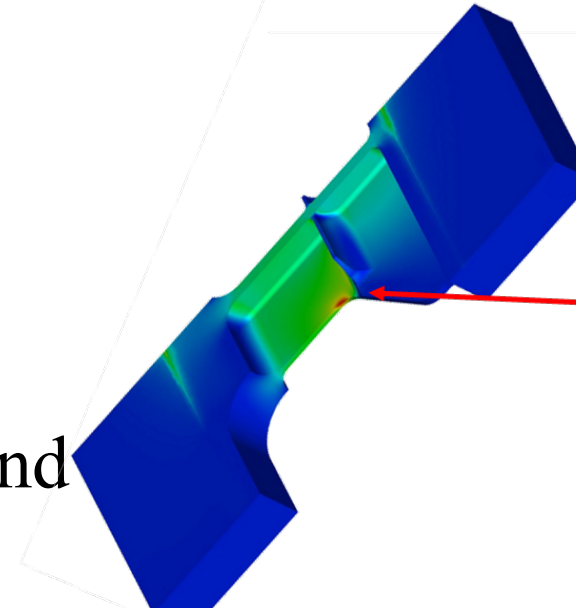
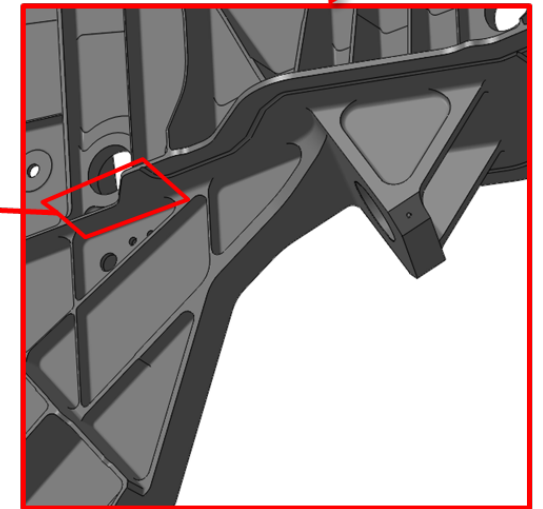
- Location Cracked Thru Thickness and Propagated Down Flange in Durability Test
- Subcomponent Testing Included
  - 3 Baseline, No EDM notch tests
  - 1 Baseline, EDM notched test
  - 2 LSP, No EDM notch
  - 1 LSP, EDM notched
- Tested in a 110kip MTS Frame
  - 6inch wide grips used – bending was a factor
- All Tests Failed in the Test Section
- Baseline Test Lives Matched for Fatigue and Crack Growth
  - Avg. first marker band found at 0.0323inch

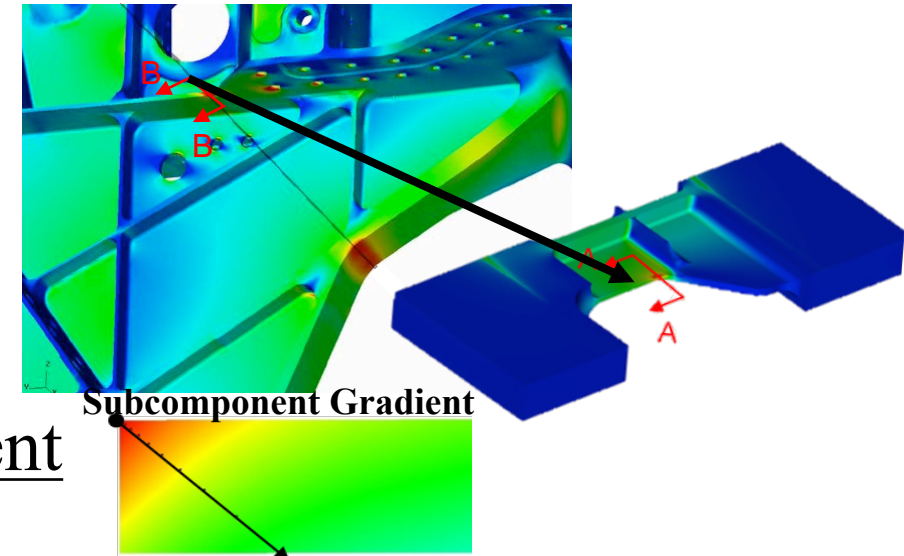
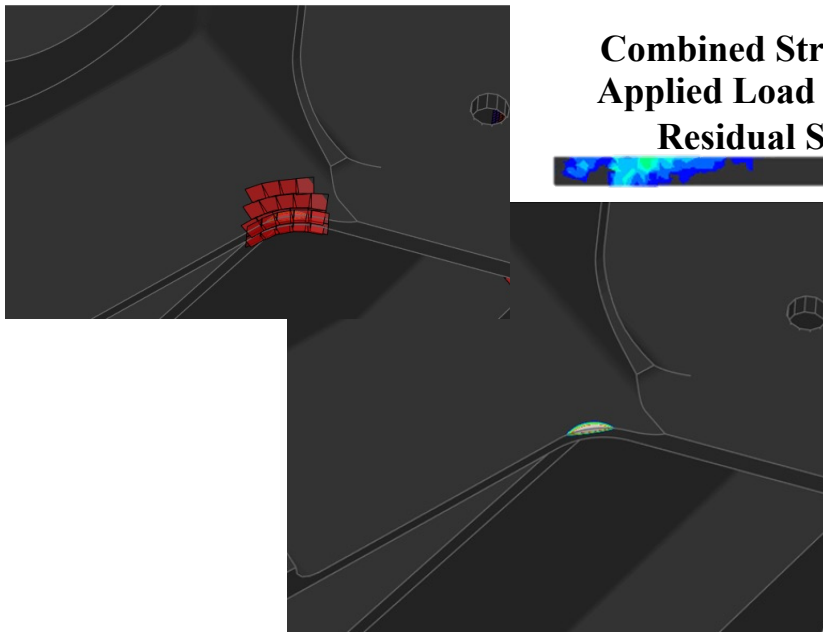
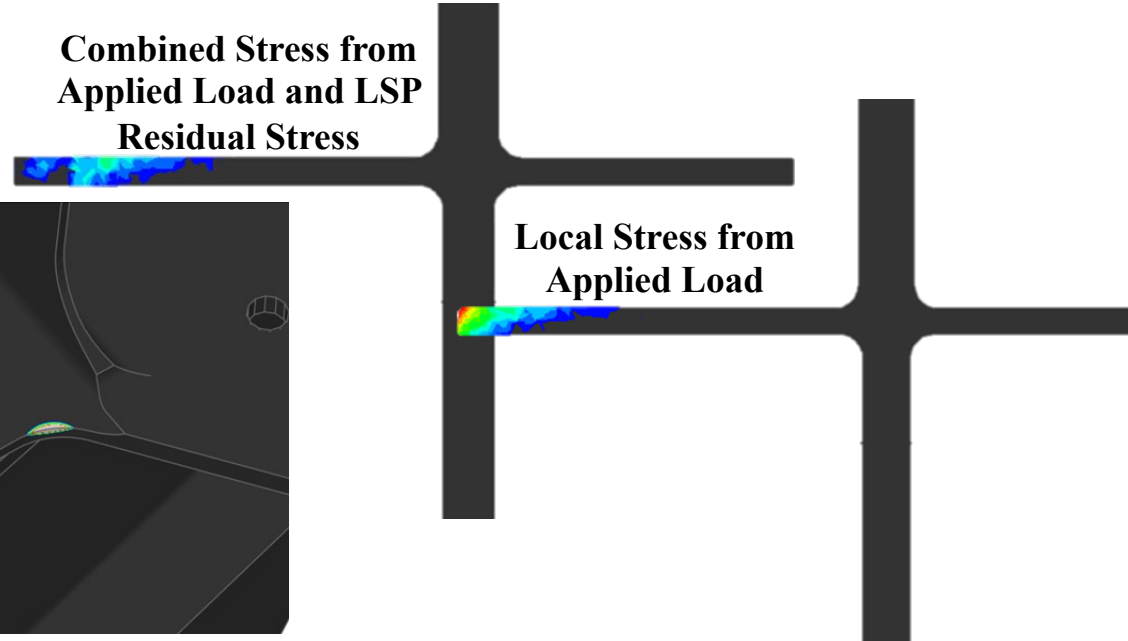
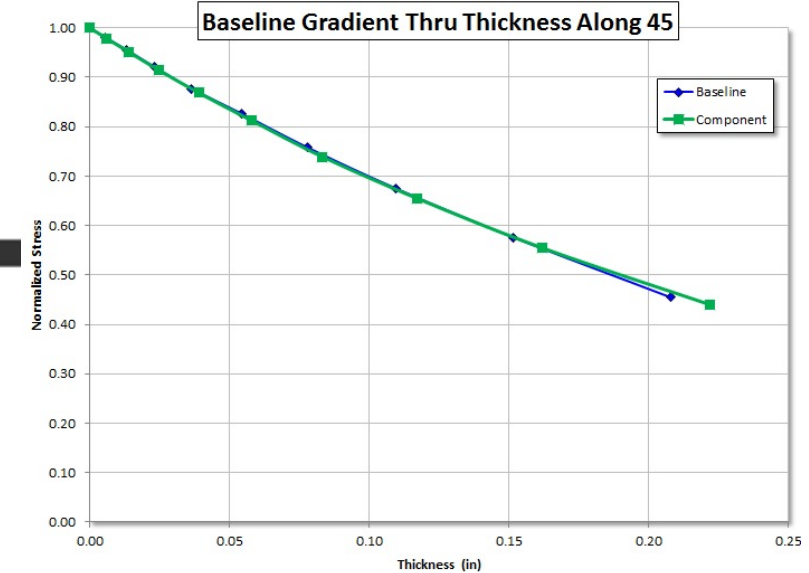
- All Subcomponents Failed at Critical Location
- All Subcomponent Tests Exceeded Requirement
  - Fatigue test – **2x** the life requirement
  - Crack Growth test – **2.5x** the life requirement
- Thinner Structure with Steep Shallow Stress Gradient

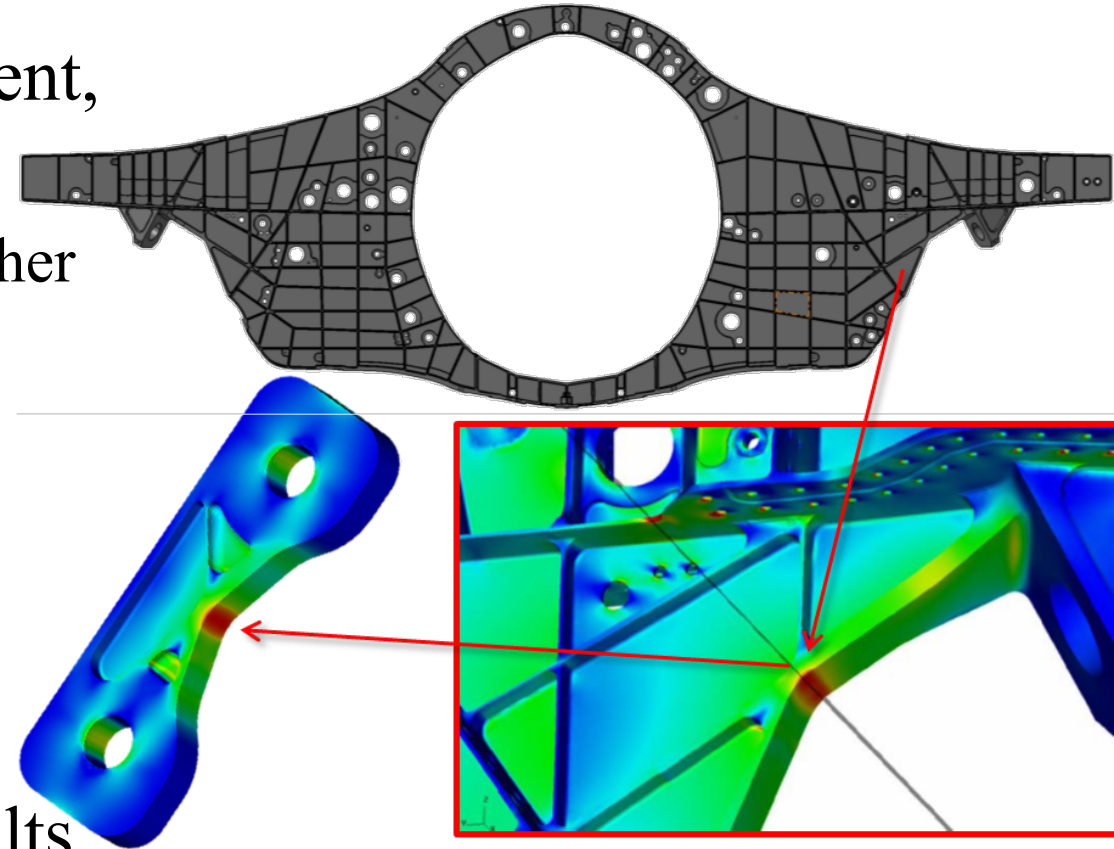
- Area Found Fully Cracked During Full-Scale Test
- Subcomponent Design Matched Stress Gradient, Peak Stress, and Stiffness
  - Stress gradient depth, width much different than other two locations
- Subcomponent Testing Included
  - 4 Baseline, No EDM notch tests
  - 1 Baseline, EDM notched test
  - 5 LSP, No EDM notch
- All Baseline Tests were Consistent with Results from FSDT for Fatigue and Crack Growth
- Tested in 220kip MTS Load Frame

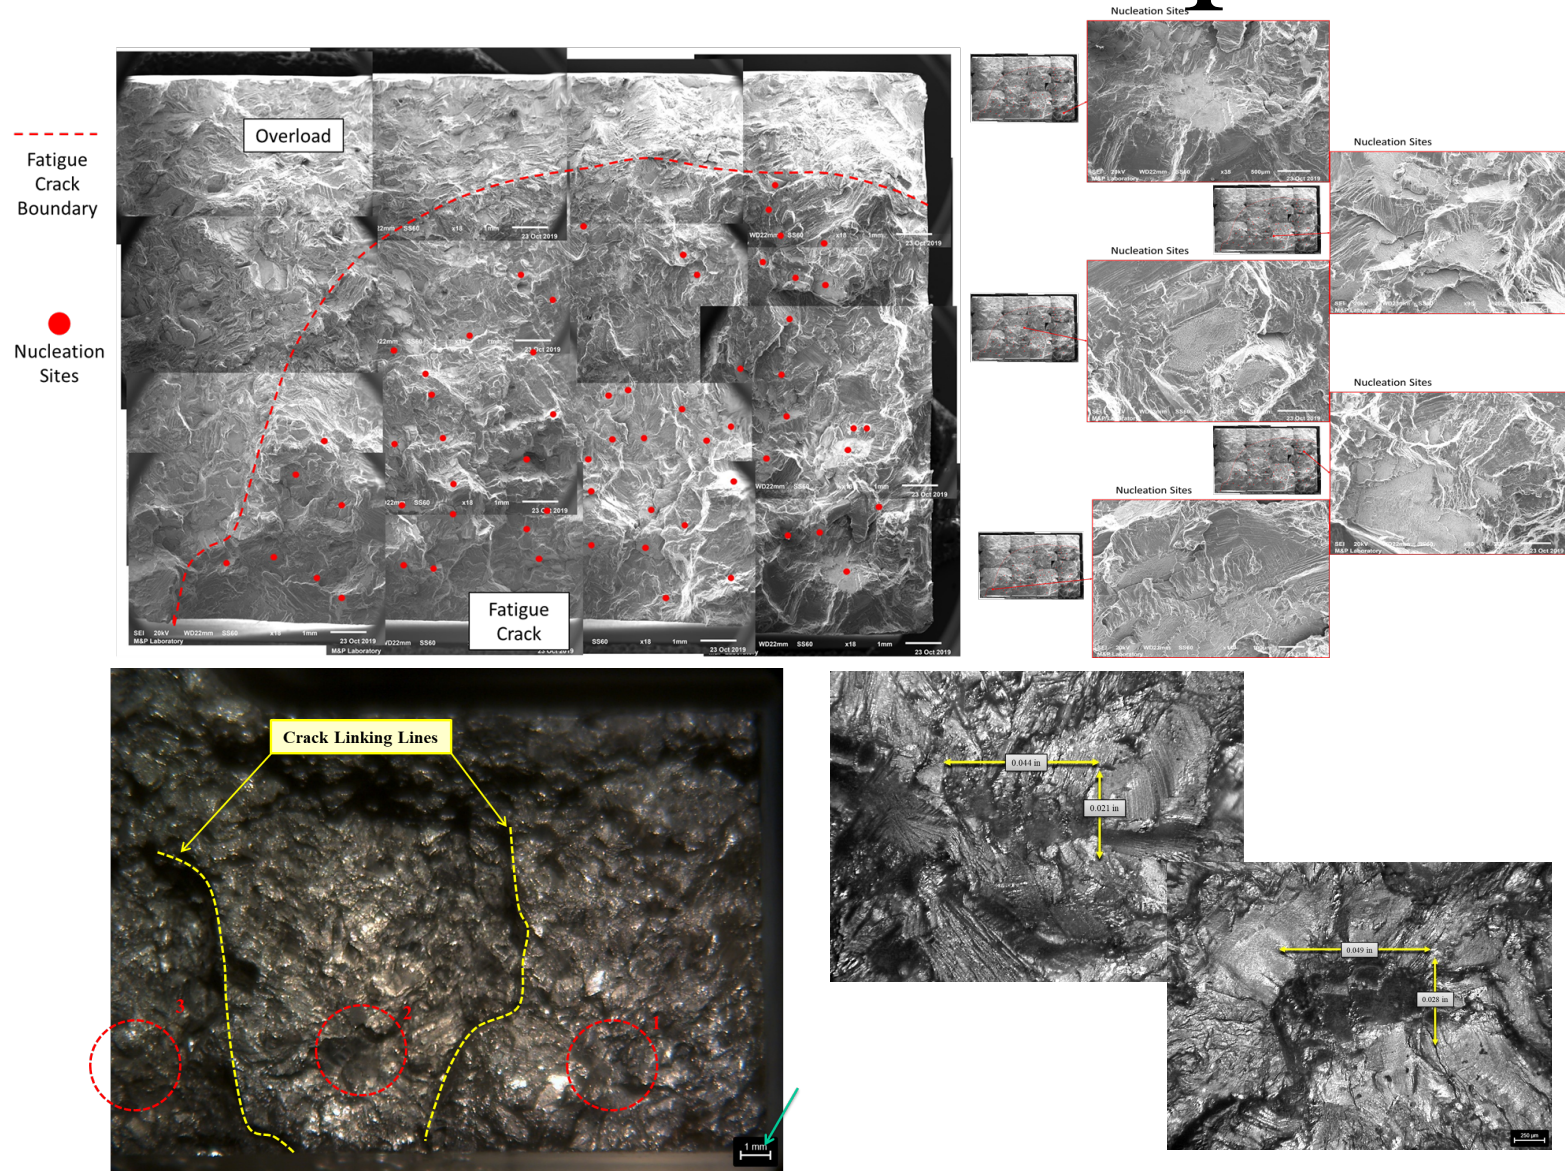
- Performed 2 Tests with LSP “Wrapped” Around Critical Area
- Next Test Performed with Half the Number of Layers and Not “Wrapped” but “Horseshoed”
- 3<sup>rd</sup> LSP Configuration was a Middle Number of Layers
- **All LSP Fatigue Tests Nucleated and Failed from Subsurface Cracks**

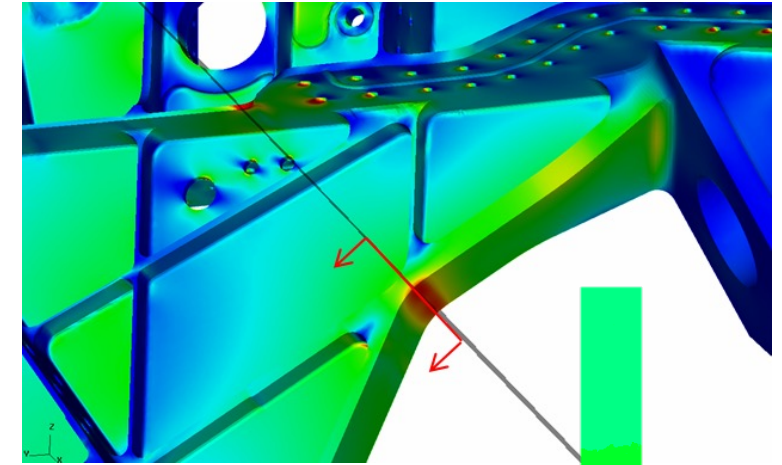
- Most Engineered Residual Stress Processes Perform Best With Shallow, Sharp Stress Gradients
  - Trunnion Runout and Fuel Floor Flange exhibit this stress feature
- Armpit Has Gradual, Deep, Stress Gradient
  - Almost like a pure tension test, but with a bit of bending
- All Introduced Compression Must be Balanced with Tension
  - Applied load and residual tension combined to a very high internal tensile stress region
  - Stress move towards the free surface
  - Potential cleaving of grains

Cross-Section at Armpit with LSP Applied  
No Far-Field Load Applied

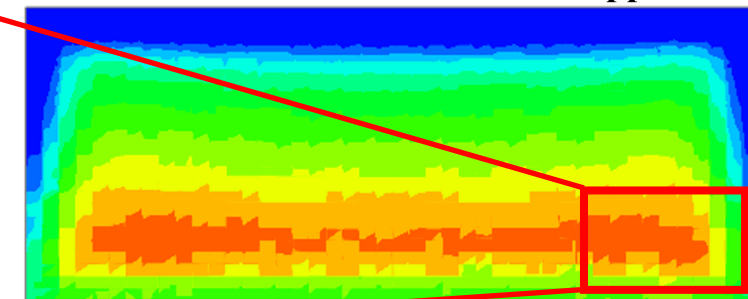
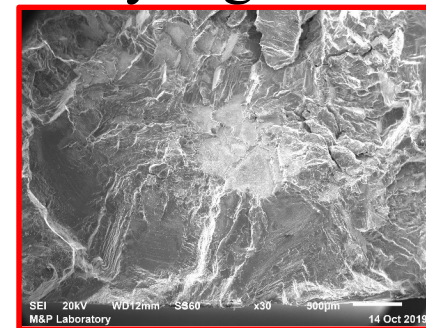
Far-Field + LSP Residual Stresses Applied

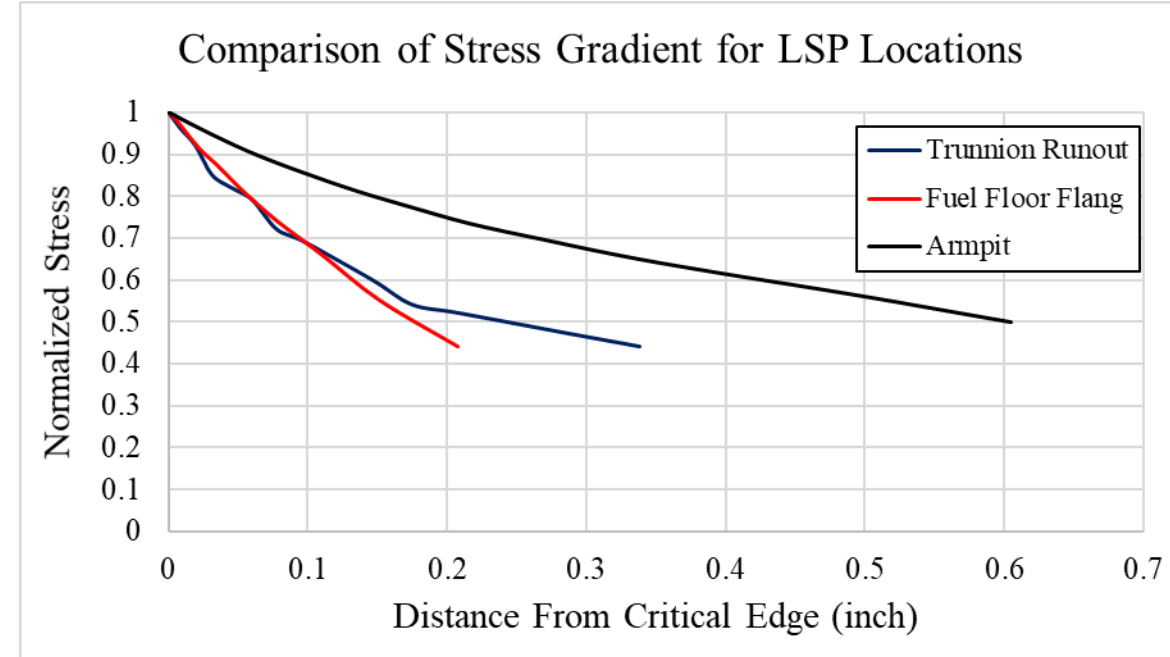
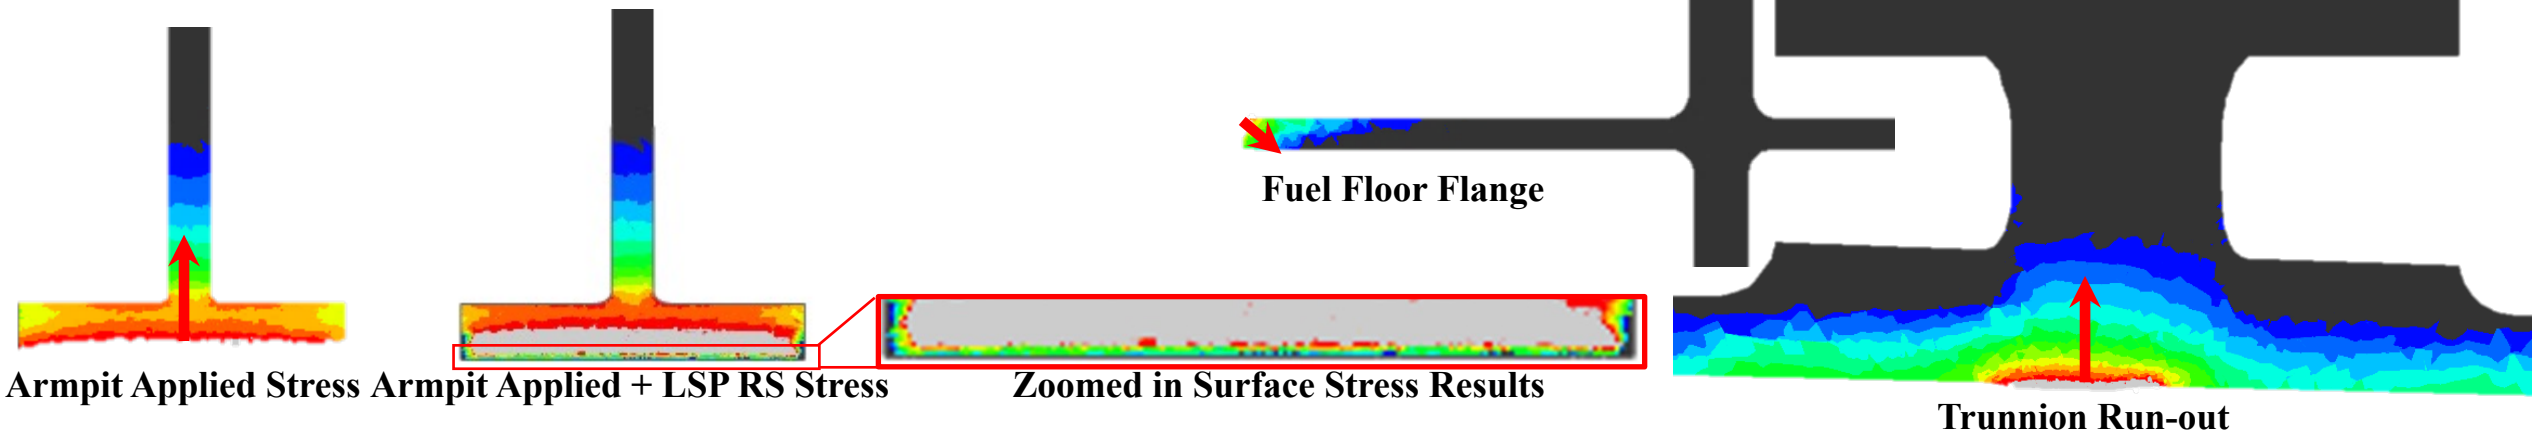
- Comparison of FEA Simulation Stress Gradient Results Between All Locations
  - Scales are all the same
  - Far-field applied load shown
- Trunnion and Fuel Flange Have Material to Balance the Application of LSP
- Initial LSP Process for Armpit Introduced Surface Compression, BUT Pushed Tension Subsurface and NO Material to Balance Stresses
