## Assessment of “as-printed”, machined & post processed additive layer manufactured (ALM) Ti-6Al-4V for aerospace applications

S. L. Jenkins <sup>a</sup>, D. P. Davies<sup>a</sup>, J. P. Fuhr <sup>b</sup>, S. McArthur <sup>c</sup>

<sup>a</sup> Leonardo Helicopters, United Kingdom, steve.jenkins@leonardocompany.com,  
david.davies@leonardocompany.com

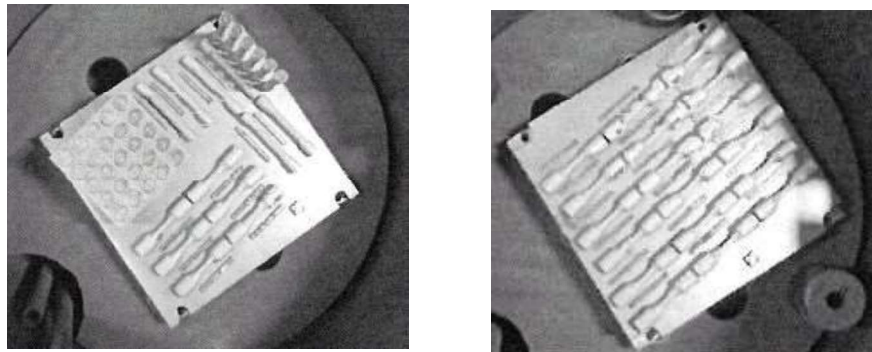
The test coupons were built to the required specimen dimensions (see Plate 1). The machine used to produce these coupons was a 3TRPD M280 400W system which built up these samples in 60 µm layers, using standard Ti-6Al-4V processing parameters.

Plate 1 – Location of ALM Test Coupons on Build Platens

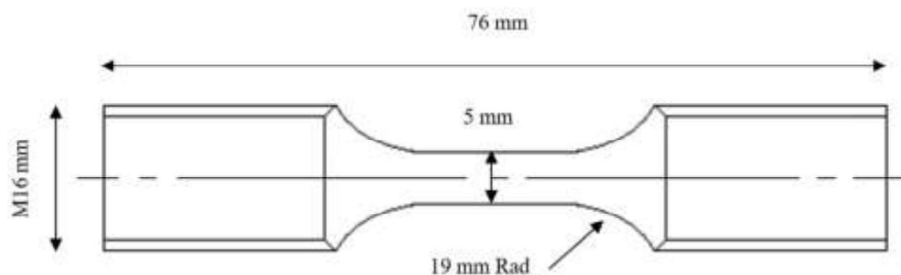
The axially loaded fatigue specimen used during the fatigue evaluation trials was based on a Vibrophore design (see Figure 1). The fatigue test specimens were either manufactured to the defined dimensions (“As Printed”) or were machined down to the dimensions from ALM cylinders (“As Machined”). Regardless of the manufacturing method employed the specimen was designed according to dimensional requirements specified in ASTM E466. In the case of the ALM cylinders the waisted section was machined to a 0.4 µm finish.

**Figure 1 – Vibrophore Fatigue Test Specimen Design**

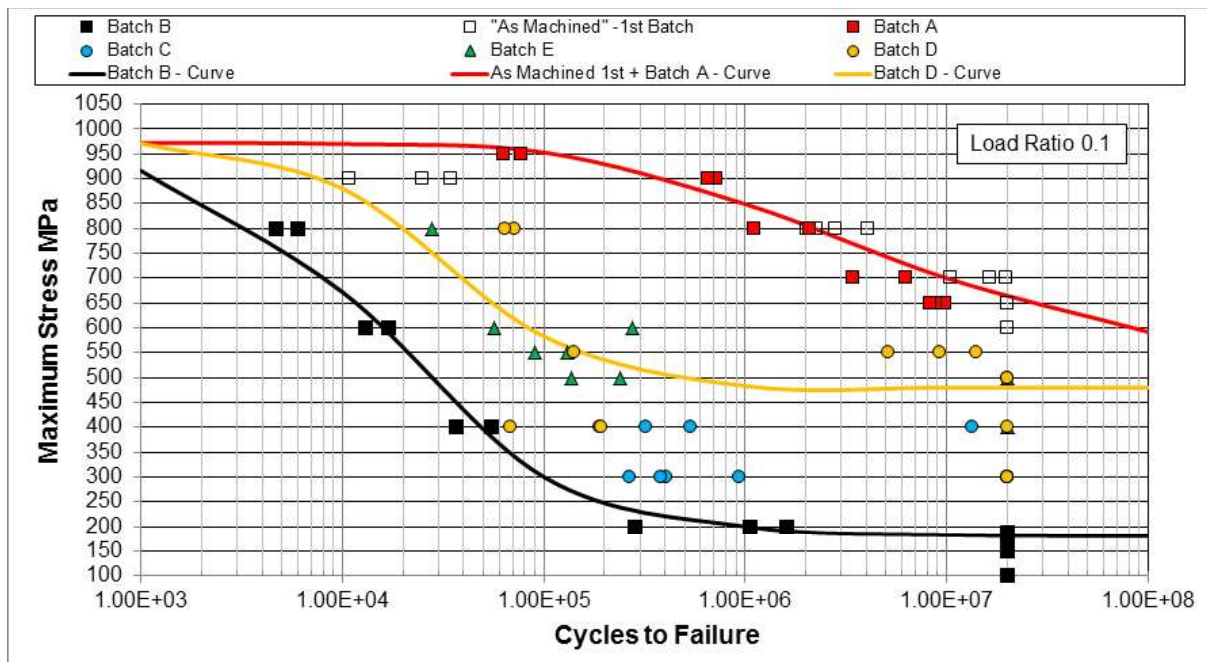
The fatigue results obtained from each group of specimens are shown in the S-N curves produced from the individual data points for each data set are shown in Figure 2.

**Note:** Samples tested to 20 million cycles are defined as “run outs” (i.e. un-failed samples)

**Figure 2 – S/N Curve of “As Printed” [Batch B], “As Machined” [Batch A], Shot Peened [Batch C], Shot Peened/Superfinished/Shot Peened & Superfinished [Batch D] or Superfinished alone [Batch E]**

From the S/N curve data shown in Figure 2 it can clearly be seen that the ALM “As Printed” batch was inferior by a factor of three when compared to the ALM “As Machined” batch. The inferiority of the “As Printed” ALM is considered to be due to four main factors:-

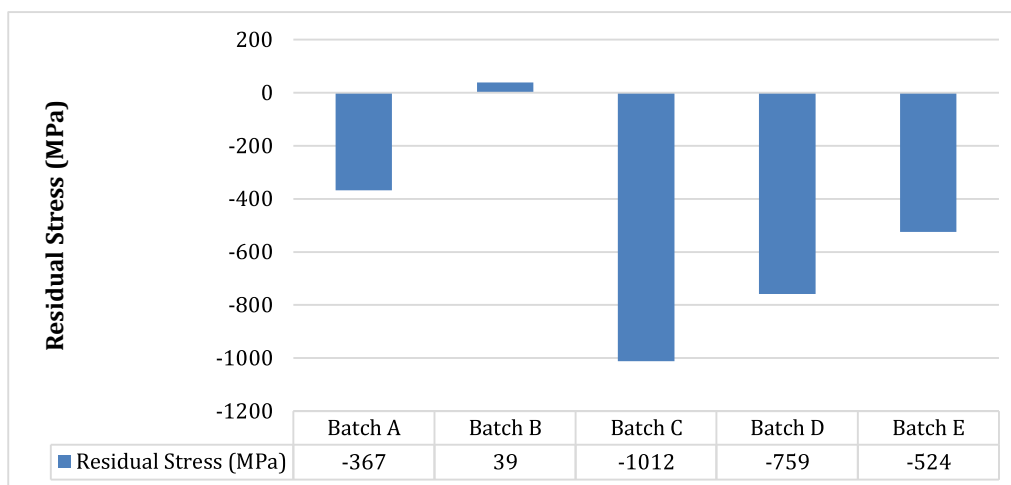
The maximum values of tensile or compressive surface residual stresses obtained from the different conditions are shown in Figure 3.

**Figure 3 – Maximum Values of Measured Surface Residual Stress: “As Machined” [Batch A ], As Printed” [Batch B], Double Shot Peened [Batch C], Shot Peened & Superfinished [Batch D] or Superfinished alone [Batch E]**

- A far higher level of surface roughness.
- The presence of partially melted grains and unfused regions at the surfaces creating surface re-entrant angles/notches at the surface, see Plate 2.
- The surface layer was in a slightly tensile residual stressed state, see Figure 3.
- Evidence of surface oxidation(alpha case contamination), see Plate 2.

By investigating the changes in fatigue endurance in relation to superfinishing, the following observations were made in the relation to Figure 3.

- Improvements in the “As Printed” fatigue endurance were observed as a result of superfinishing modifying both residual stress and surface roughness. The most likely explanation for the change in residual stress were due to the abrasive removal of the alpha case. It is interesting to note that the level of compressive residual stress was less with the MIC CASE superfinishing process which was probably due in part to the chemically assisted abrasion process used which is known to be less abrasive than the more straightforward abrasive process used by Fintek.

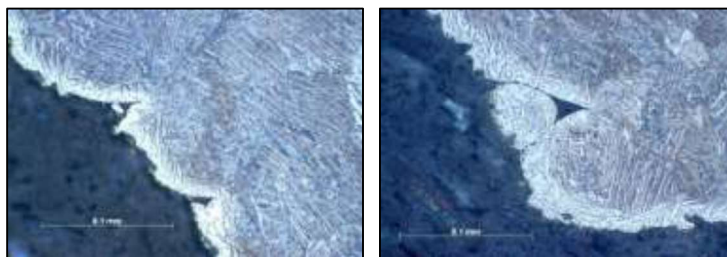
**Plate 2 – Micro-section taken through “As Printed” ALM showing Evidence of Surface Oxidation, Un-melted Powder Particles and Re-entrant Flaws/Notches**

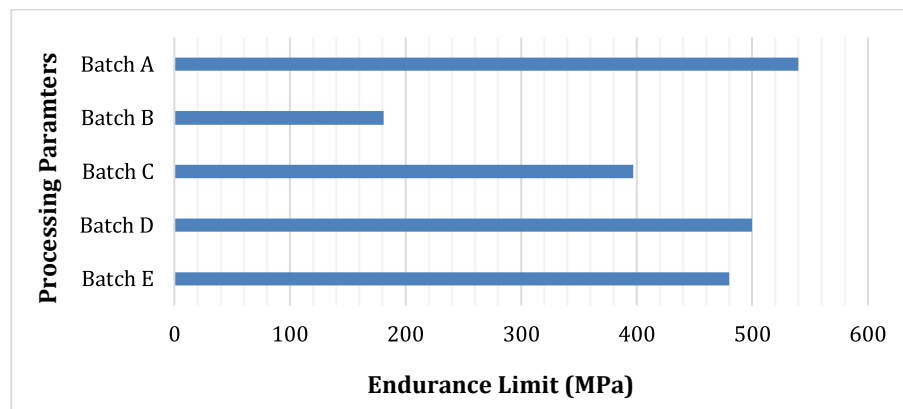
An overview of the influence of all three investigated post ALM treatments showing their largest improvements to the fatigue performance can be seen in Figure 4, in relation to the “As Machined” and “As Printed” conditions.

Figure 4 – Endurance Limit of “As Machined” [Batch A ], As Printed” [Batch B], Double Shot Peened [Batch C], Shot Peened & Superfinished [Batch D] or Superfinished alone [Batch E]

Shot peening with different parameters, i.e. size, intensity and type of shot resulted in different fatigue endurance of “As Printed” ALM. Figure 4 shows the largest improvement by using a dual shot peening process consisting of steel shot followed by glass bead peening. Regardless of the type of peening employed, fatigue life of the “As Printed” batch was always enhanced. Although definite conclusions cannot be drawn due to the small sample size, i.e. in most cases single samples, the following general data trends were observed:

The effect shot peening combined with super-finishing had on the fatigue endurance of “As Printed” ALM can also be seen in Figure 4, Batch D. From this figure it is interesting to note that the fatigue endurance limit was approaching the value obtained with the “As Machined” batch. Although the difference in endurance limits between the “As Machined” Batch A and the Shot Peened and Superfinished samples from Batch D would appear to be less than 8%, care must be taken with this assumption due to the curve shape of Batch A. Hence based on Figure 4, a more realistic difference of 15% should be assumed.

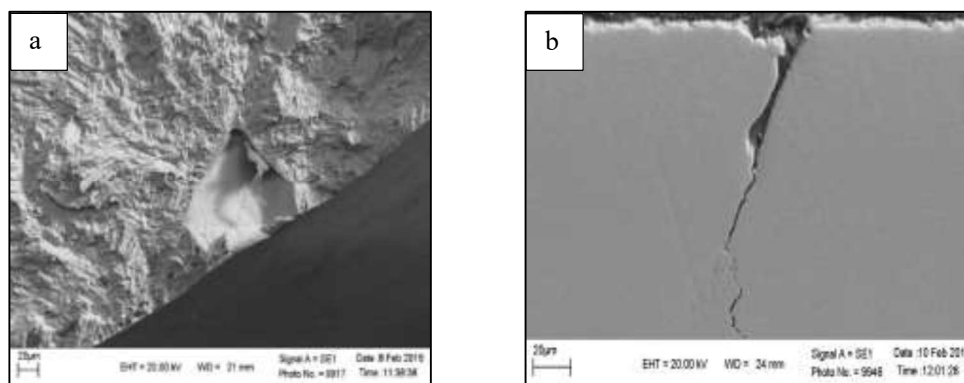
**Plate 3 - Surface Failure from a) Cold Shut/Oxide Film and  
b) Micro-section showing a Fatigue Crack Initiating from a Cold Shut**

- While improvements in the “As Printed” fatigue endurance were observed through the use of superfinishing, large variations in fatigue endurance between the two superfinishing processes (i.e. MIC & Fintek) were observed. The most likely explanation for this difference is likely to be due to the amount of material removed during superfinishing. With regards to the Fintek process approximately 0.16 mm was removed per surface, whilst the MIC CASE process removed far less material, i.e. 0.07 mm. However, while the Fintek superfinishing process removed more material, cold shuts/re-entrant flaws/defects from the ALM process were still present, see Plate 3a. Moreover the presence of these ALM processing defects were further confirmed by the fractographic evidence in which the majority of the fatigue failures were still initiated from the surface. The detrimental influence that these cold shuts/re-entrant flaws/defects have on fatigue can be seen in Plate 3b in which a secondary fatigue crack has initiated from one of these features.
